# LEADING BUILDING & PEST INSPECTIONS

## BUILDING REPORT COPY

1234 test st.  
80122

Pre-purchase property condition  
report

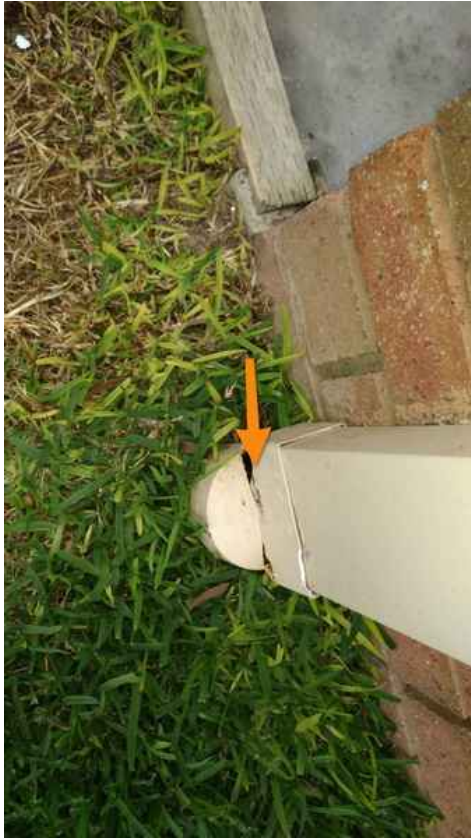
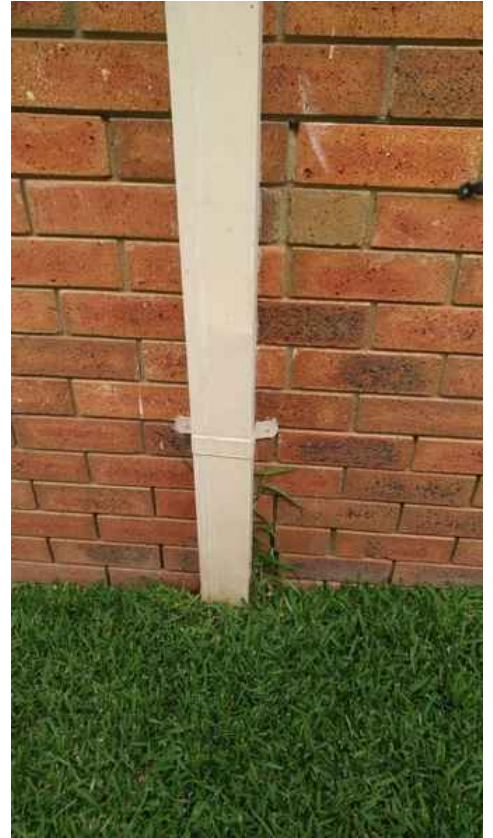
#### **LEAKING JOINT/S NOTED REQUIRING REPAIR**

Recommendation

Contact a handyman or DIY project

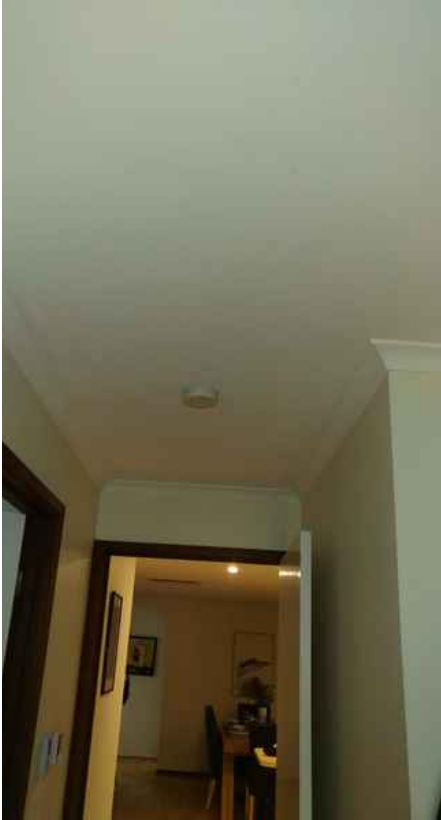
**Ceiling Conditions: Smoke alarm present but not tested**

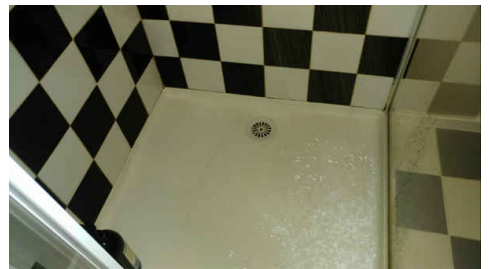
7.7.1 Shower Base Condition

**MISSING / DAMAGED CAULKING / GROUT JOINT NOTED**

Recommendation

Contact a qualified tile contractor

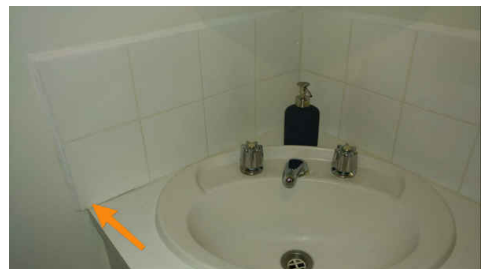
7.13.1 Splashback

**CAULKING MAINTENANCE NEEDED**

MAINTENANCE/MONITOR

Seal all gaps and voids to prevent water penetration

Recommendation

Contact a handyman or DIY project

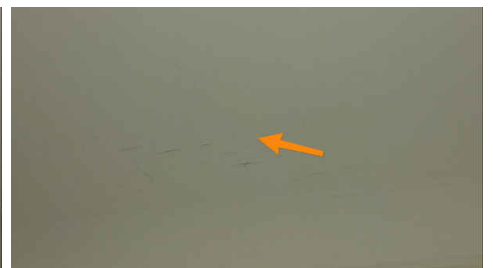
8.4.2 Ceiling Conditions

**PEELING PAINT OBSERVED**

Recommendation

Contact a qualified professional.

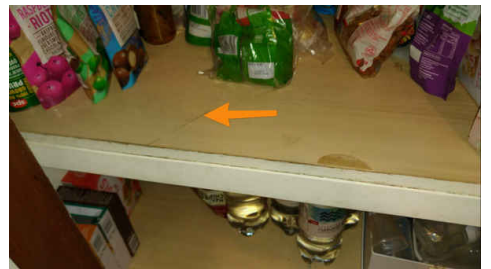
9.13.1 Pantry Shelving/Draws Condition

**CABINET LAMINATE PEELING OFF**

DEFECT

Contact a qualified professional.

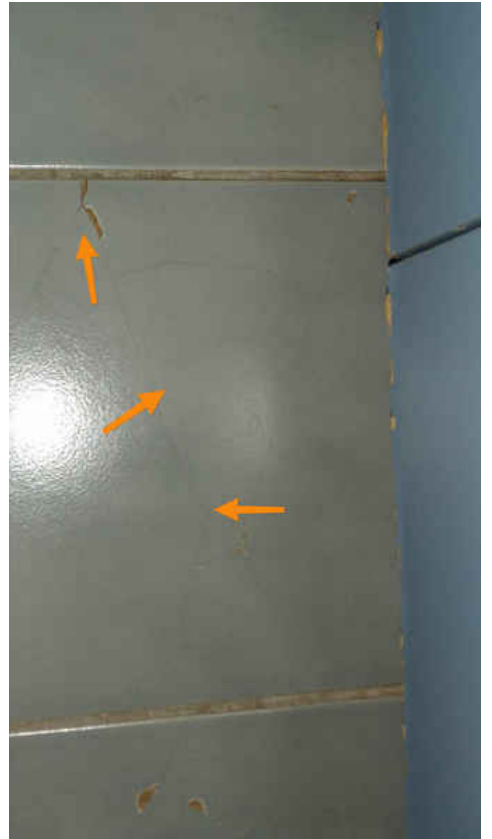
### 13.5.2 Floor condition

#### **CRACKED TILE(S) NOTED**

#### Recommendation

Contact a qualified tile contractor

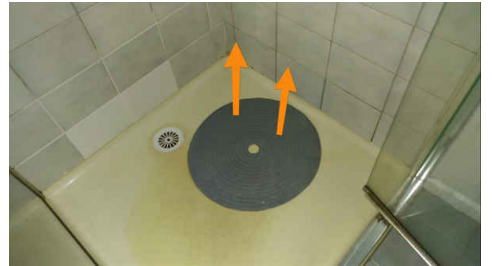
13.7.1 Shower Base Condition

**MISSING/DETERIORATED GROUT**

Recommendation

Contact a qualified tile contractor

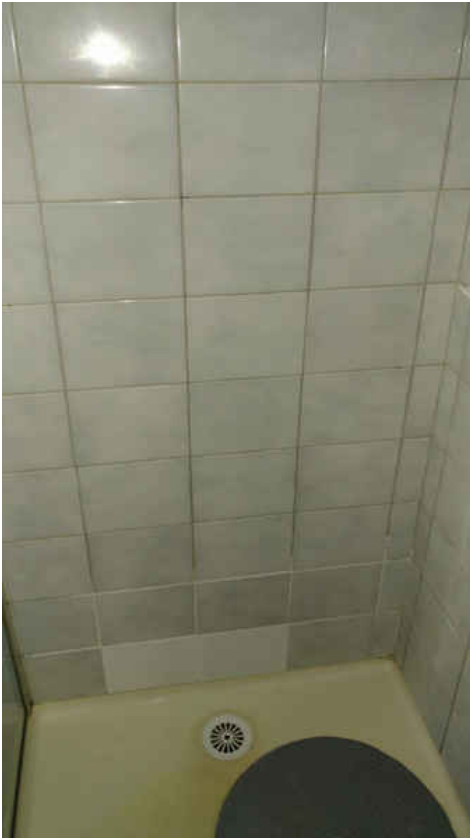
13.8.1 Shower surround

**CAULKING MAINTENANCE REQUIRED**

Recommendation

Contact a handyman or DIY project
