LEADING BUILDING & PEST INSPECTIONS

BUILDING INSPECTION COPY

TEST ST
5000

Sample Report
JANUARY 12, 2019

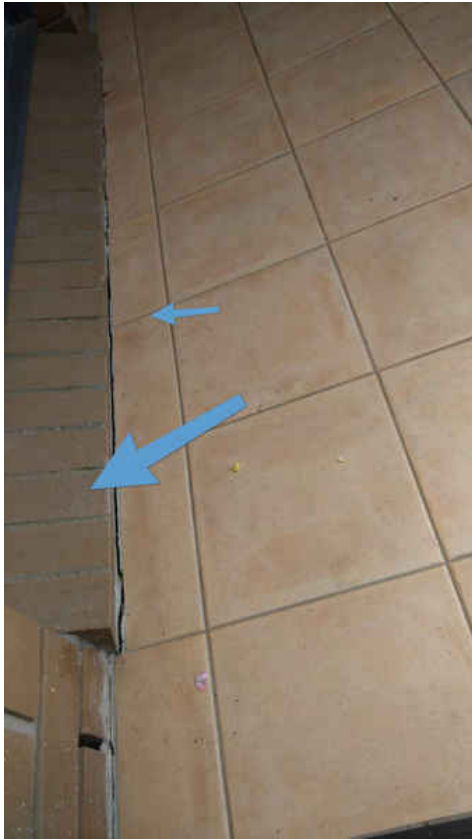
4.6.1 Floor Condition

DAMAGED GROUT OBSERVED

Would recommend using silicone on floor wall joins to allow for expansion / movement

Contact a handyman or DIY project

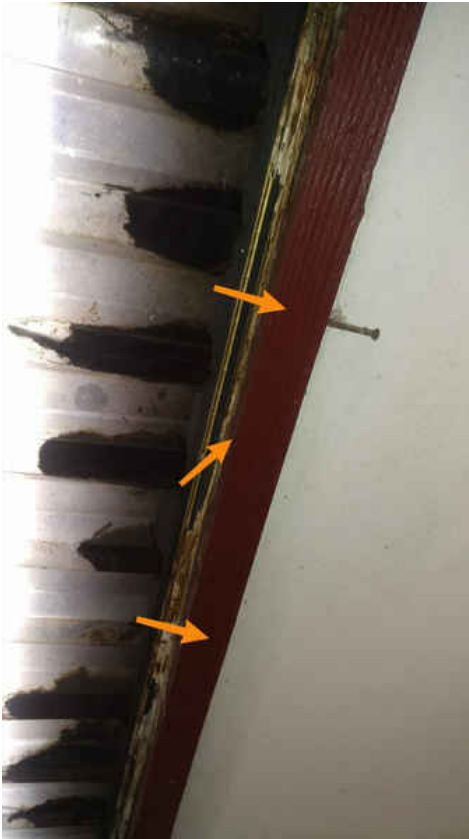
**DAMAGE NOTED, REPAIRS CARRIED OUT.
UNSURE OF THE EFFECTIVENESS OF THESE REPAIRS.**

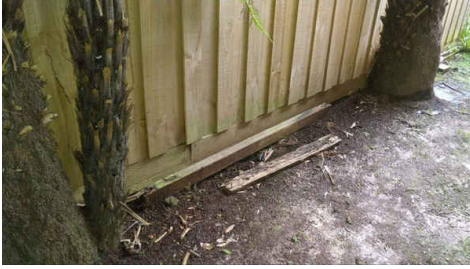
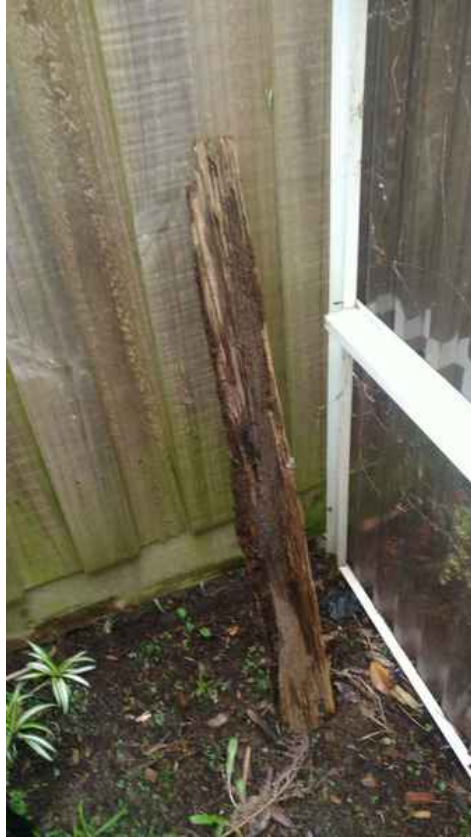
TERMITE CONDUCTIVE CONDITIONS

These items create conditions prone for termites activity

Recommend removal of items from the building exterior.

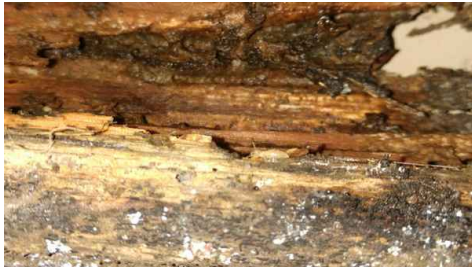
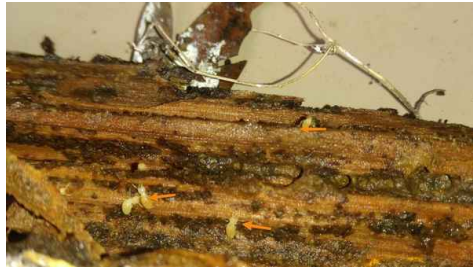
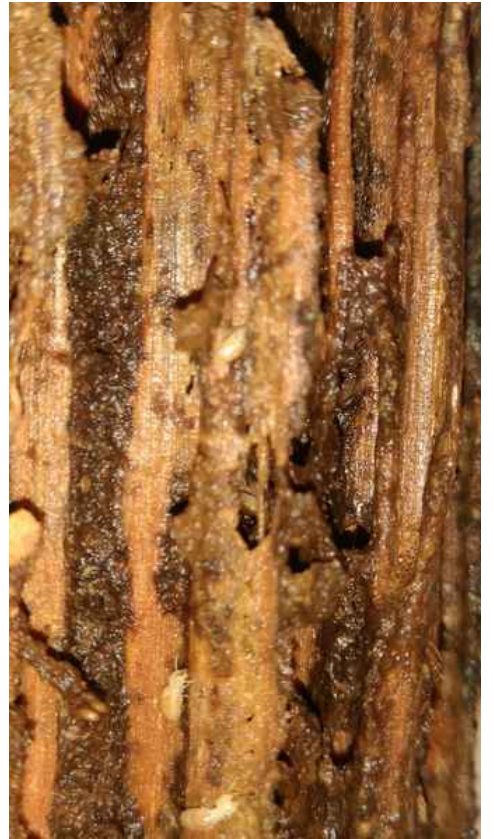
6.6.2 Grounds Observations

TERMITES SEEN ON PROPERTY

Recommend timber pest baiting system be installed to treat termites and protect home / investment

Contact a qualified professional.

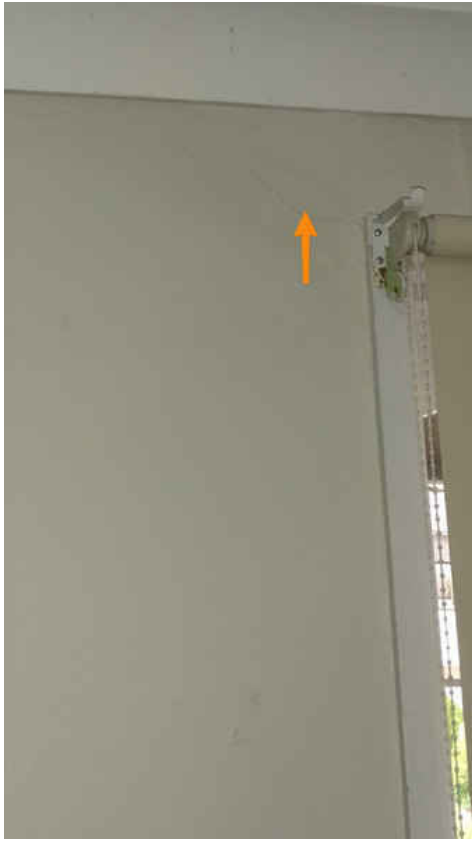
9.3.1 Wall Condition

EVIDENCE OF REPAIR

Contact a qualified professional.

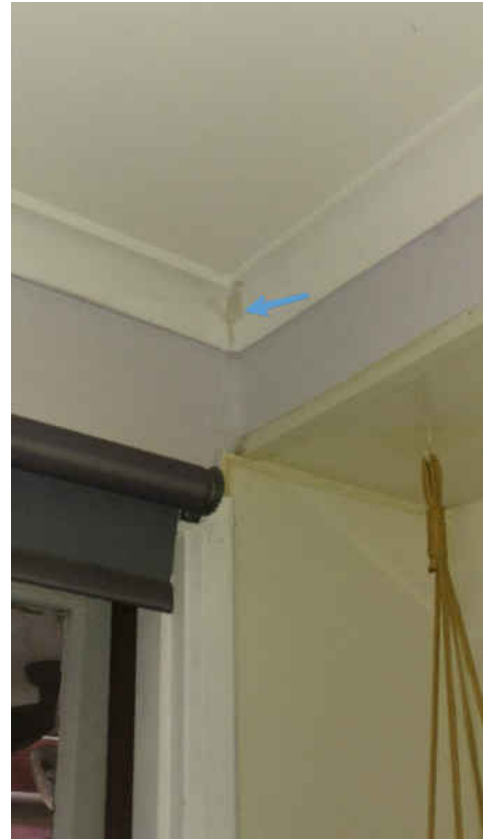
11.3.1 Walls Condition

**EVIDENCE OF REPAIRS
OBSERVED**

Unable to determine the effectiveness of these repairs.

Recommend sanding and re painting to enhance cosmetic appearance

Contact a handyman or DIY project

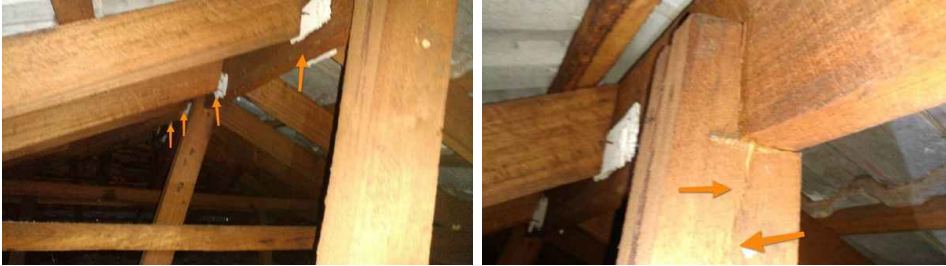
Ventilation : No roof ventilators observed

Contact your builder.
