LEADING BUILDING & PEST INSPECTIONS

BUILDING REPORT COPY

TEST ST
5000

Pre-purchase property condition
report

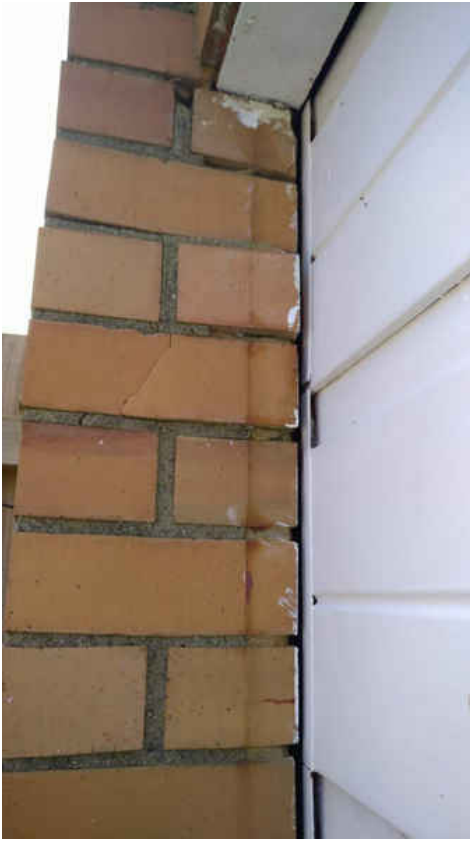
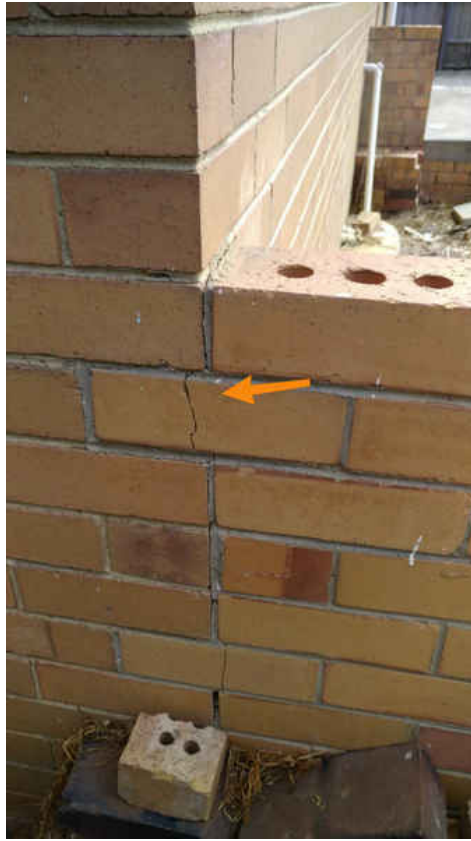
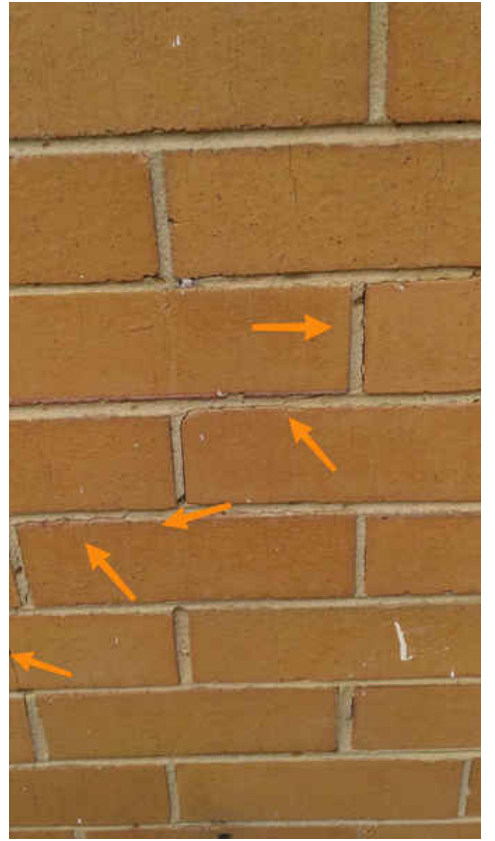
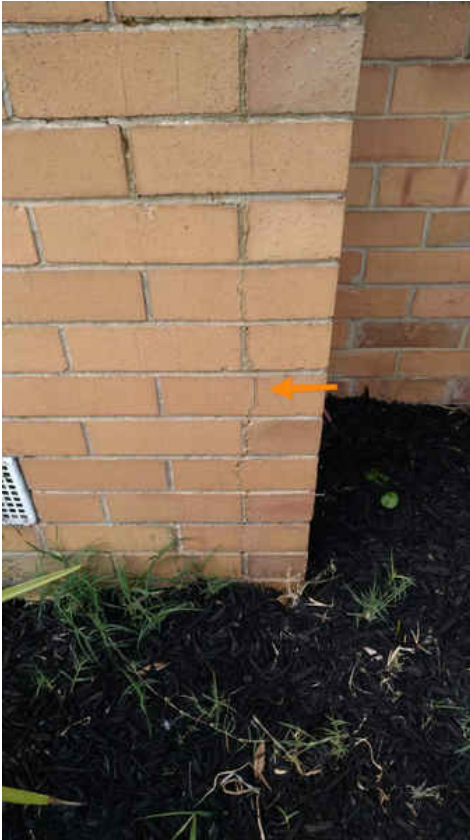
3.2.1 Wall Cladding

CRACKING - DAMAGE CATEGORY "1" - FINE (UP TO 1MM)

Information: Although fine cracks are quite noticeable, they are often only considered to be an appearance defect, and usually do not indicate any structural damage. Generally, the cause of a fine crack is indicative of a separation between building materials and finishes (e.g. bricks, render, paint, etc.) along joints.

Cracking of this nature can generally be repaired with minor sanding, filling and/or repainting.

Monitoring of all cracking should be conducted frequently. Always contact a building inspector should crack(s) widen, lengthen, or become more numerous.

Contact a qualified masonry professional.

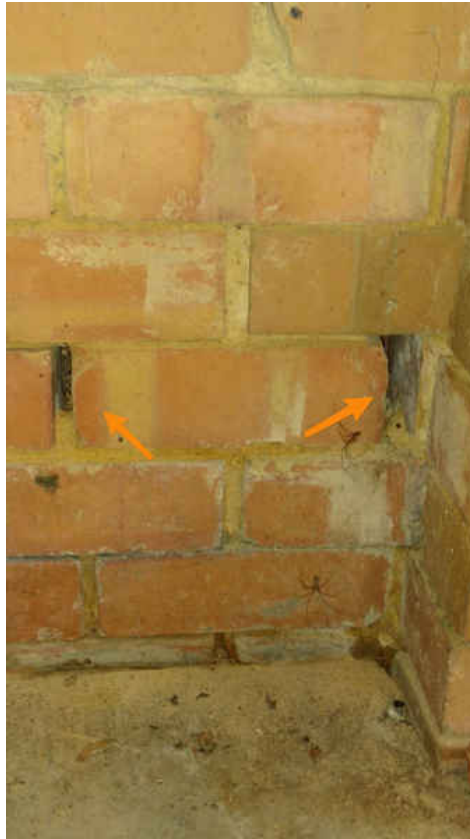
4.1.1 Wall Condition

EVIDENCE OF REPAIRS OBSERVED

Unable to determine the effectiveness of these repairs.

Recommend sanding back and re painting to enhance cosmetic appearance

Contact a handyman or DIY project

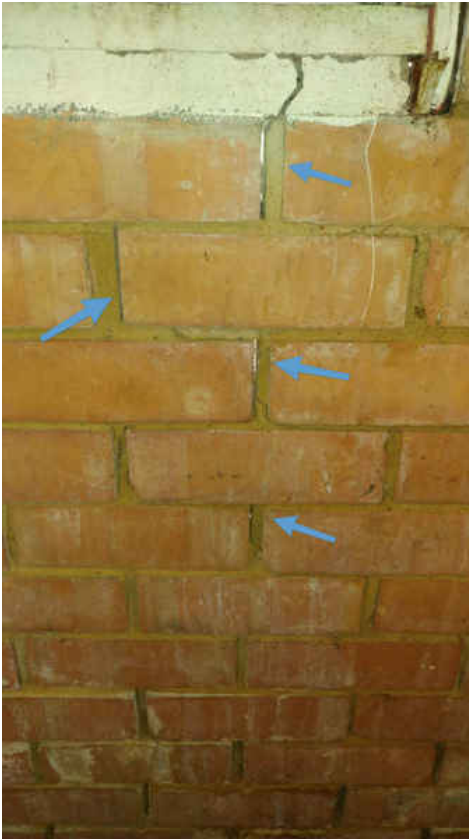
4.1.2 Wall Condition

DEFECT - SIGNIFICANT CRACKS NOTED

Recommendations: Contact a licensed Builder or Structural Engineer for further advice and recommendations

Contact a qualified structural engineer.

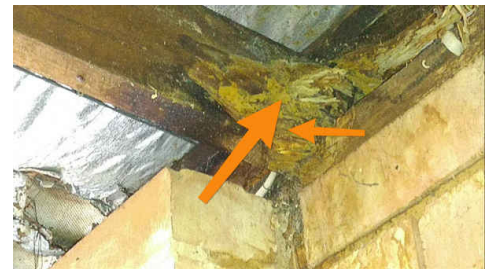
4.2.1 Ceiling Lining Condition

MAIN SUPPORT BEAM IS DECAYED AND WILL REQUIRE REPAIRS/REPLACEMENT

Contact a qualified professional.

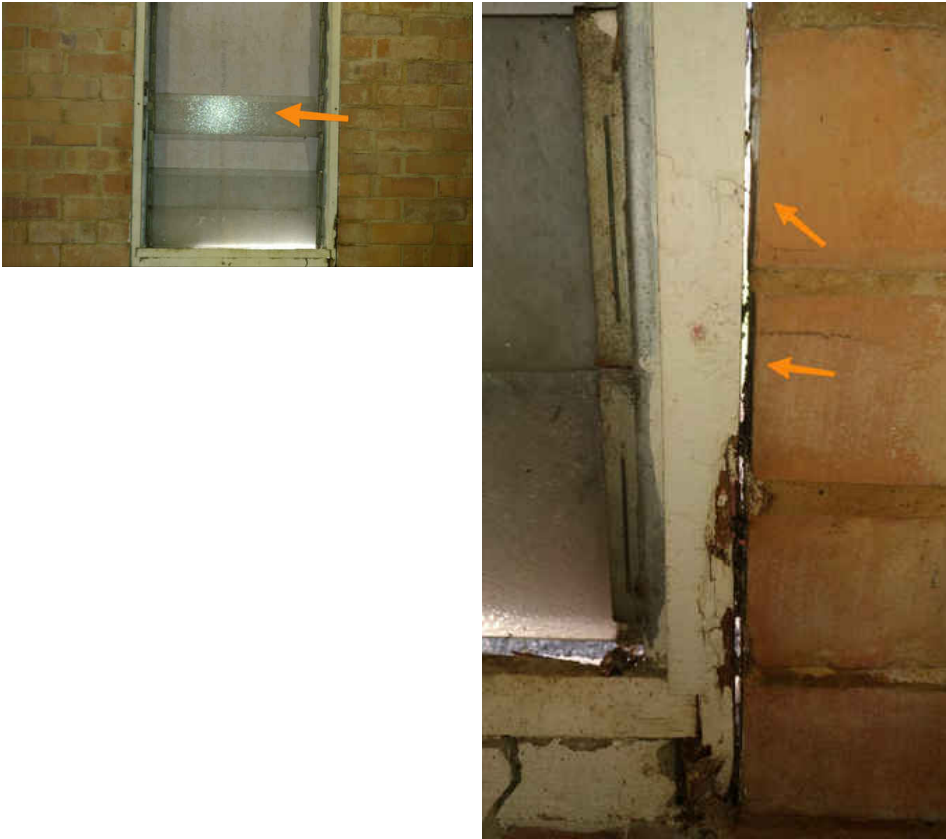
4.3.1 Window Conditions

IN THE INSPECTORS OPINION THE WINDOWS/FRAMES ARE NEAR THE END OF THEIR USEFUL LIFE

Contact a qualified professional.

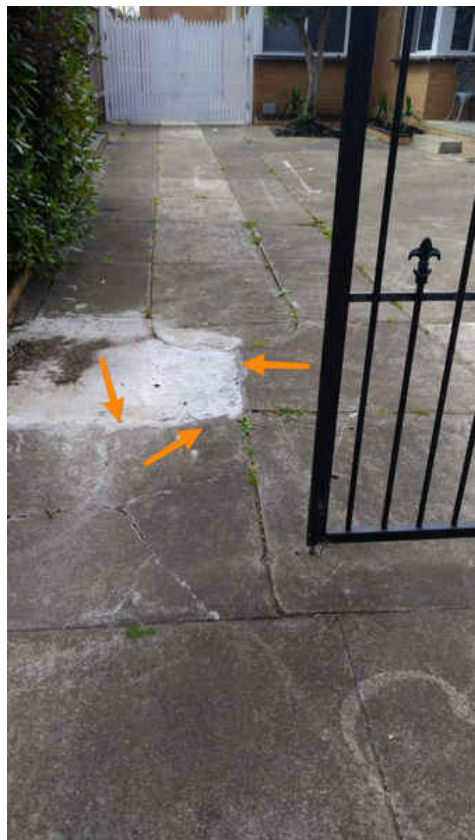
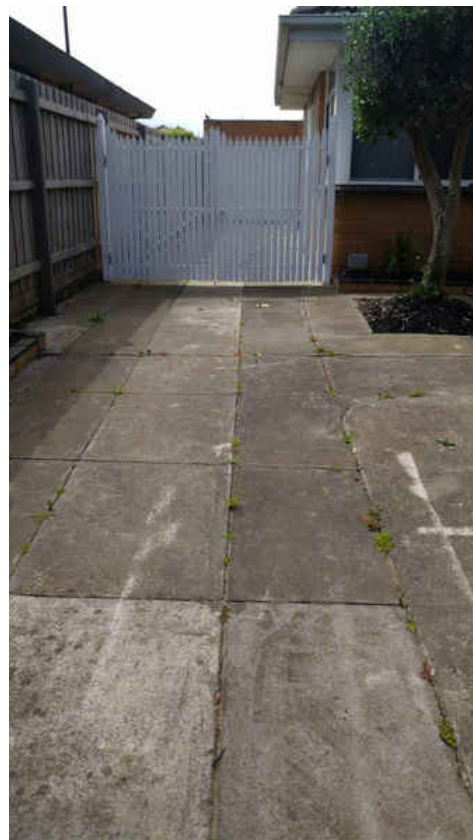
CRACKING AND/OR HEAVING TO DRIVEWAY NOTED

Due to driveway cracking we recommend a concrete professional assess with a view to replacing the affected areas.

Contact a qualified concrete contractor.

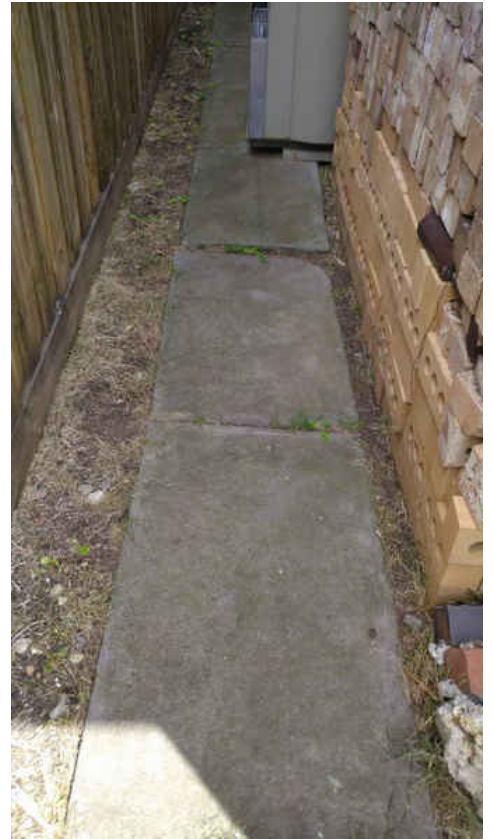
5.2.1 Walkway

COMMON CRACKS AND HEAVED/SETTLED AREAS OBSERVED

Cracking was detected to sections of concrete pathways and / or driveway. This is a common issue with a large percentage of homes and can be caused by many differing factors including poor ground preparation, inadequate steel reinforcing, etc. Repairs are not considered essential, monitor for further changes.

Contact a qualified concrete contractor.

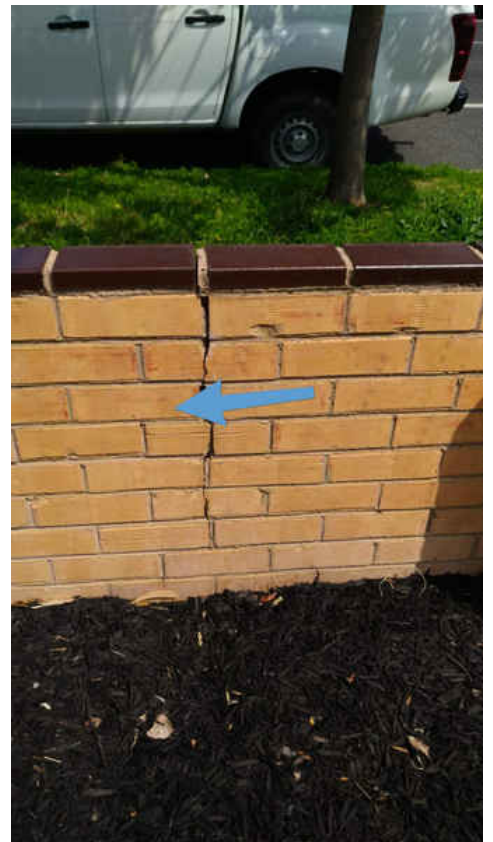
5.3.1 Fences

DAMAGED FENCE IN ONE OR MORE AREAS OBSERVED

Requires repair

Contact a qualified fencing contractor

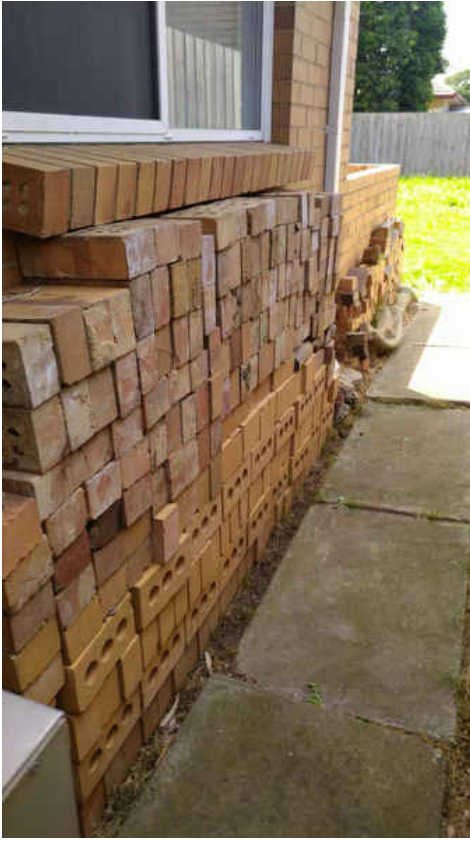
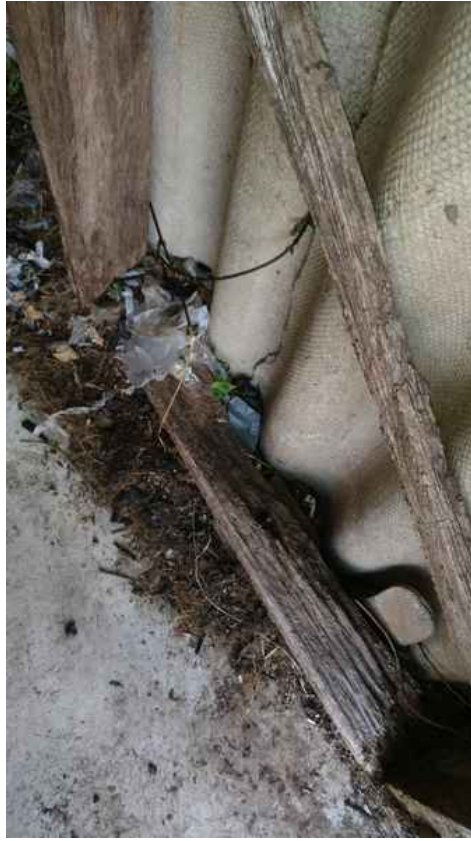
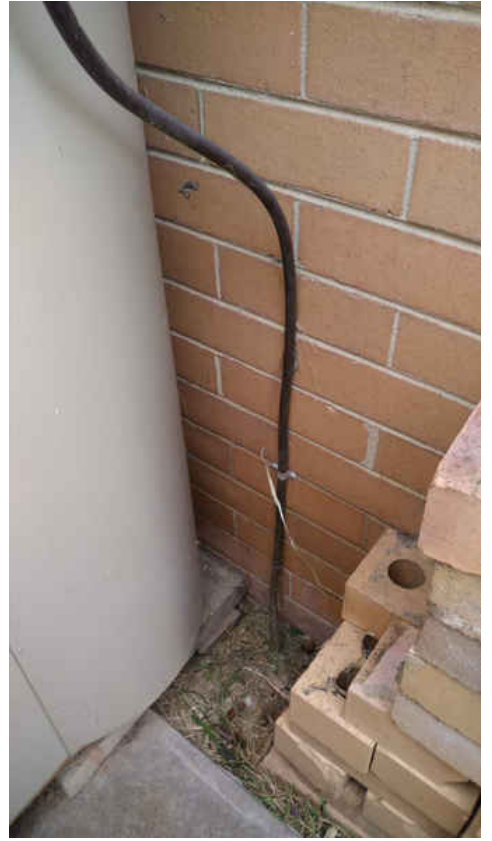
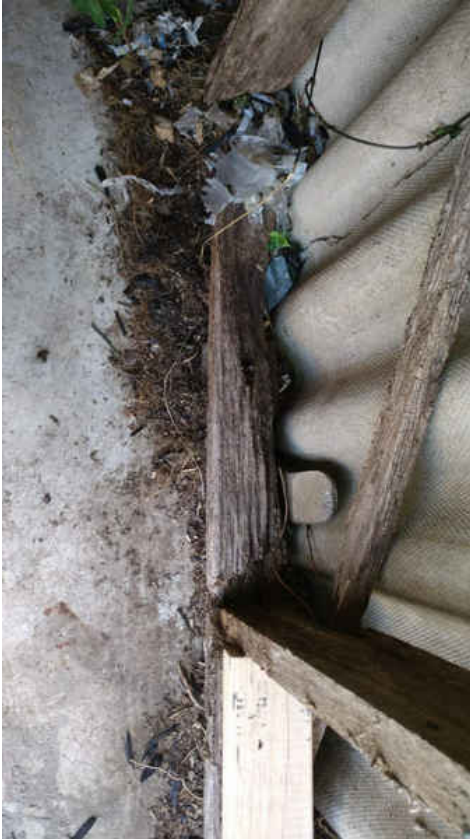
5.6.1 Grounds Observations

TERMITE CONDUCTIVE CONDITIONS

Recommend removal of items from the building exterior.
These items create conditions prone for termites activity

Contact a qualified professional.

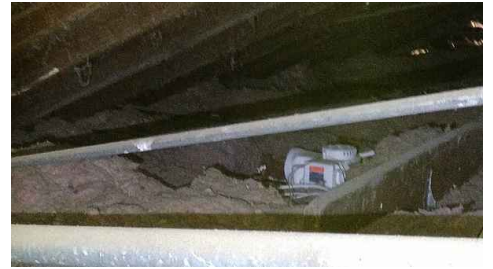
18.5.1 Ventilation

KITCHENOR/ BATH EXHAUST VENTS DIRECTLY INTO ROOF SPACE

Contact a qualified professional.
