TIMBER PEST REPORT

1234 Main St. Knoxfield VIC 3180

27/06/2021 9:00AM

1: VISUAL TIMBER PEST INSPECTION & REPORT IN ACCORDANCE WITH AS 4349.3-2010

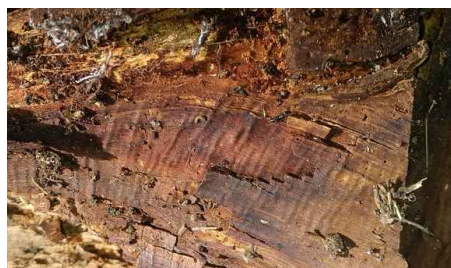
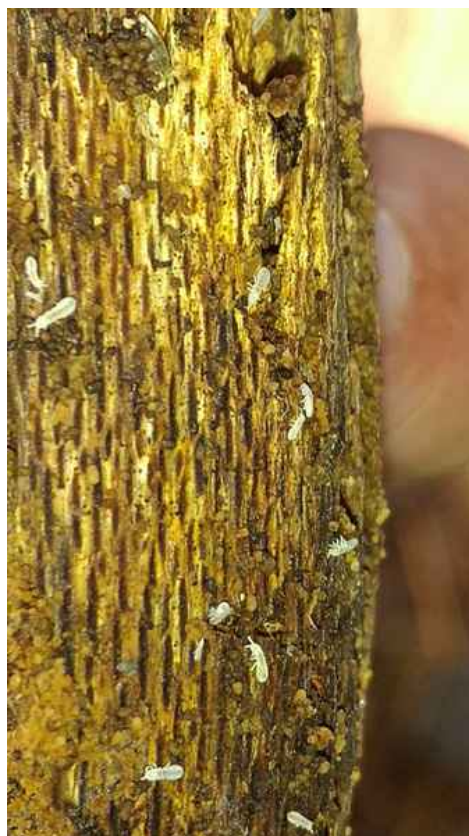
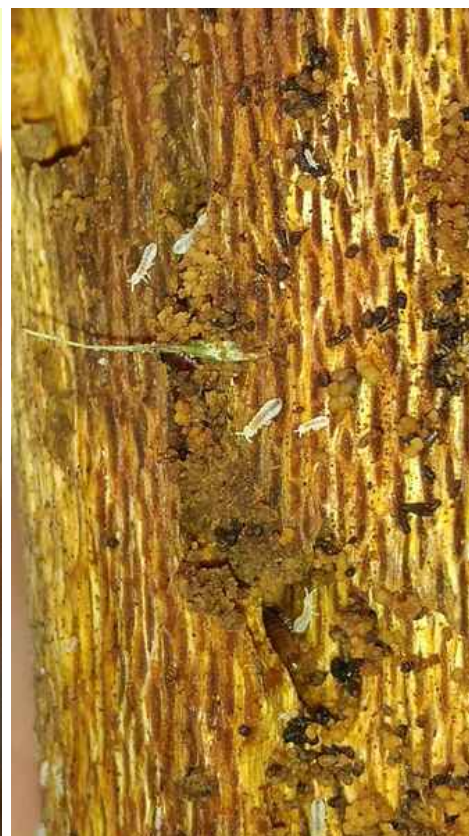
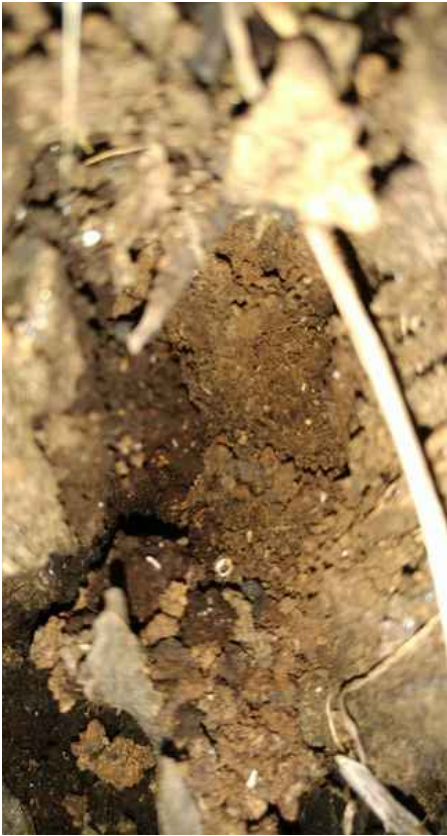
YES FOUND, Fences, Sleeper retaining wall, Subfloor door, Retaining wall, timber on ground, Dead branches of tree
Read the entire report.

Were active subterranean termites (live specimens) found

YES FOUND, Timber debris in garden, Retaining wall and gate

Recommend removal and treatment of termite nest

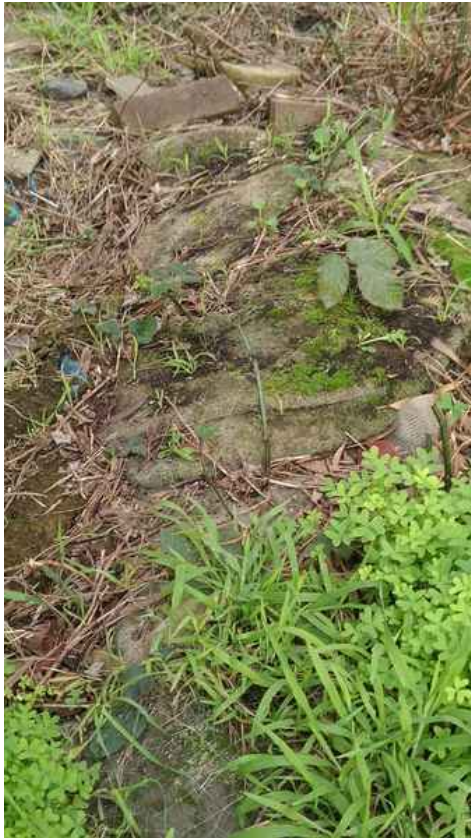
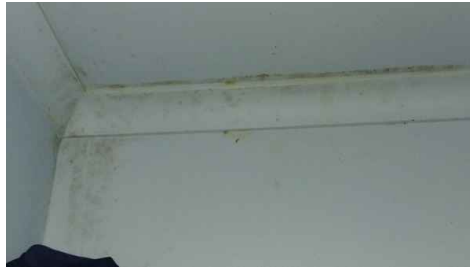
MOULD ON GROUND AND LAUNDRY

Mould found on ground and laundry
