BUILDING REPORT

1234 Main Street

Pre-purchase Building Inspection
Condition Report - AS4349.1

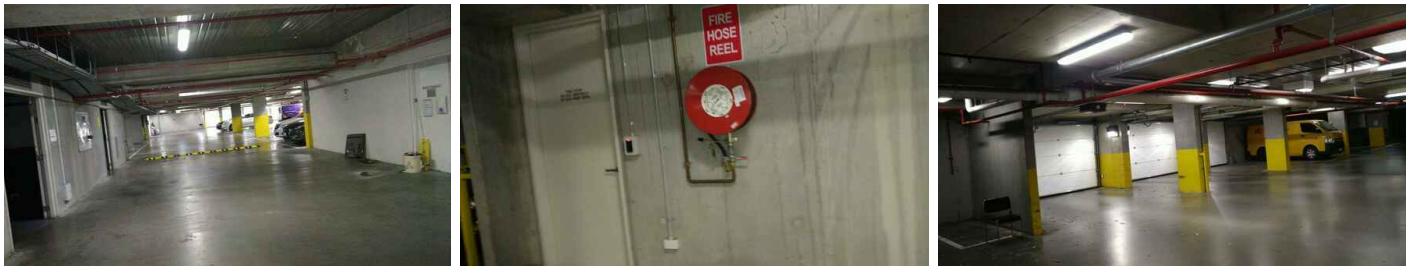
Wall Condition: In serviceable condition at time of inspection

General wear and tear noted

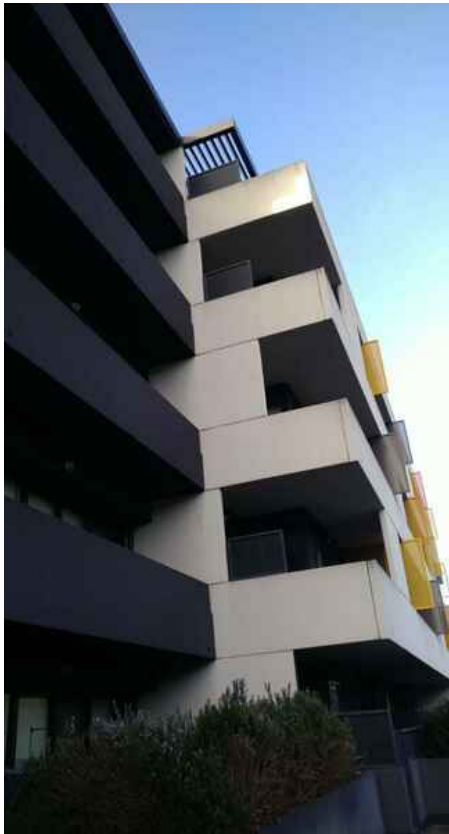
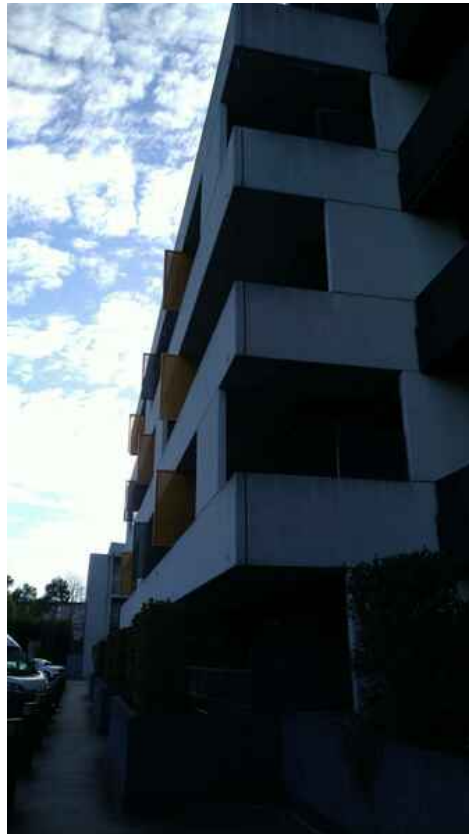
Walls: Generally walls visible to the inspector appeared to be in serviceable condition at the time of inspection

Consistent with the age and type of construction.

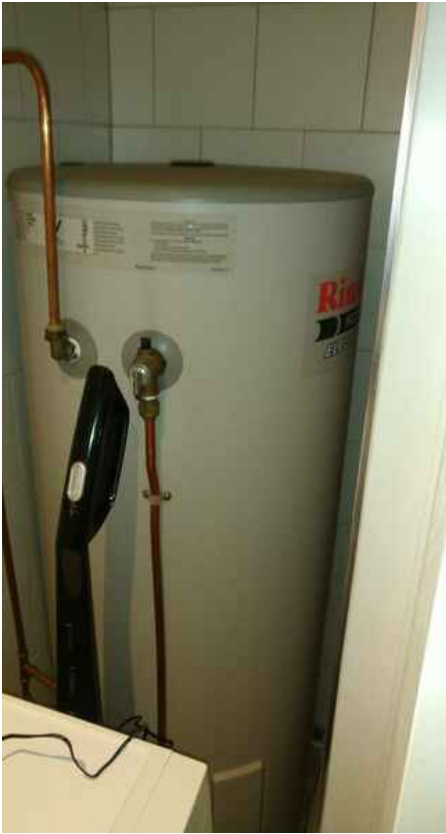
Hot-water unit/s: In serviceable condition at time of inspection

We observed during our inspection that the system appeared to be in serviceable condition. Regular maintenance and monitoring of its condition are recommended.

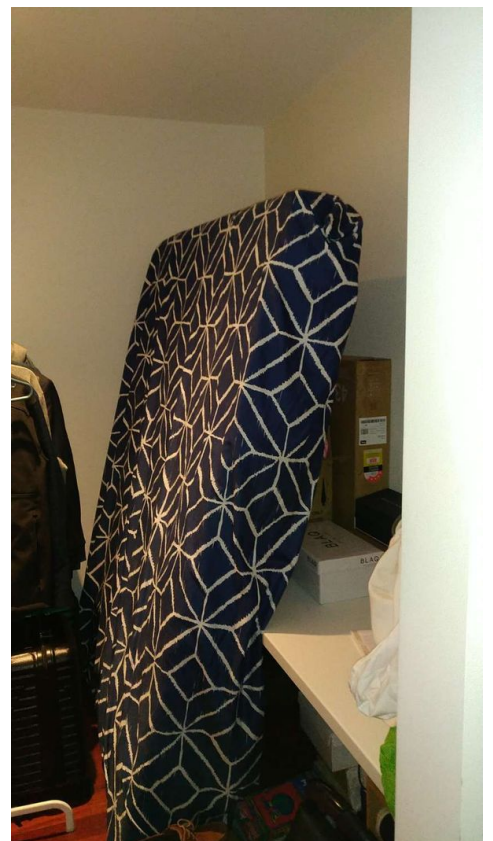
Wall Condition

LIMITED INSPECTIONS DUE TO PERSONAL STORAGE.

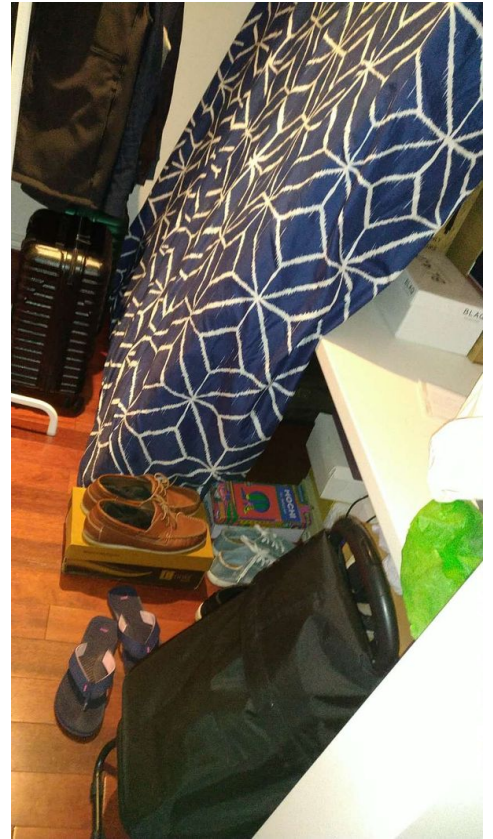
Floor Condition

LIMITED INSPECTION DUE TO STORED ITEMS OBSERVED

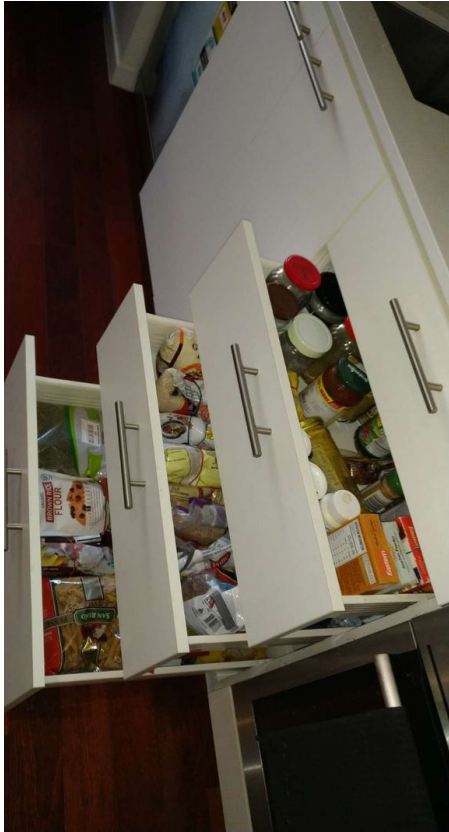
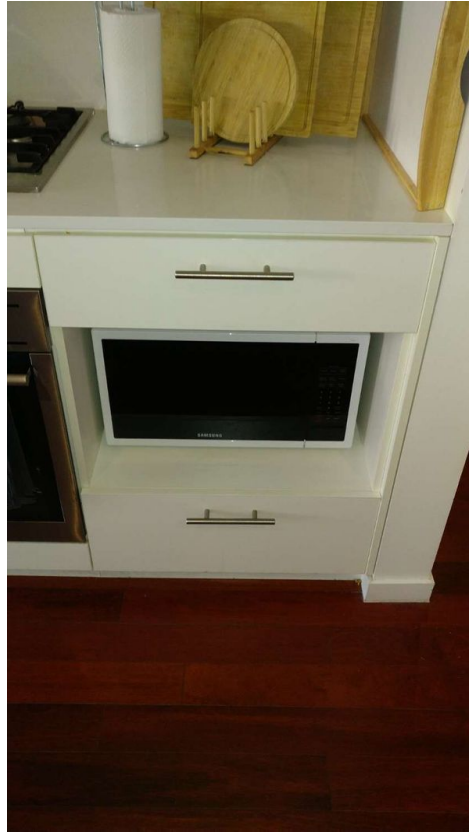
9.7.1 Splashback

DEFECTIVE

It is recommended that tile junctions be properly caulked/sealed to prevent water seeping and damage to back of cupboards.

Recommendation
Contact a handyman or DIY project

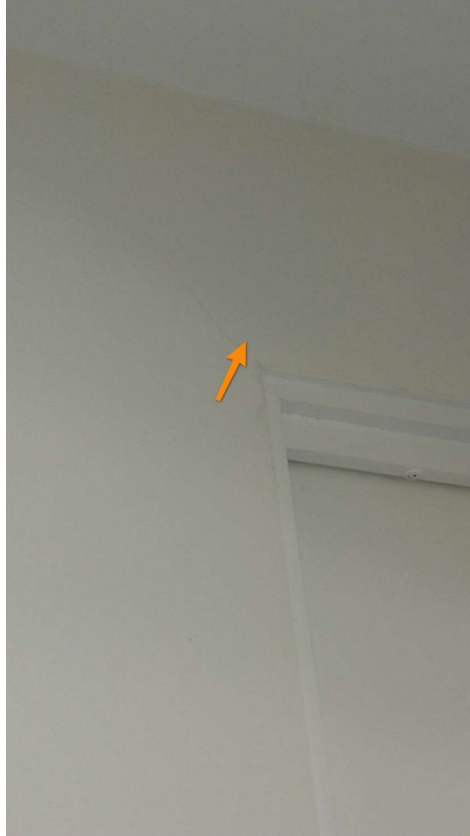
11.4.1 Wall Condition

**CRACKING - DAMAGE CATEGORY 1 - FINE (UP TO 1MM)**

Although fine cracks are quite noticeable, they are often only considered to be an appearance defect and usually do not indicate any structural damage. Generally, the cause of a fine crack is indicative of a separation between building materials and finishes (e.g. paint, plaster, etc.)

Recommend monitoring.

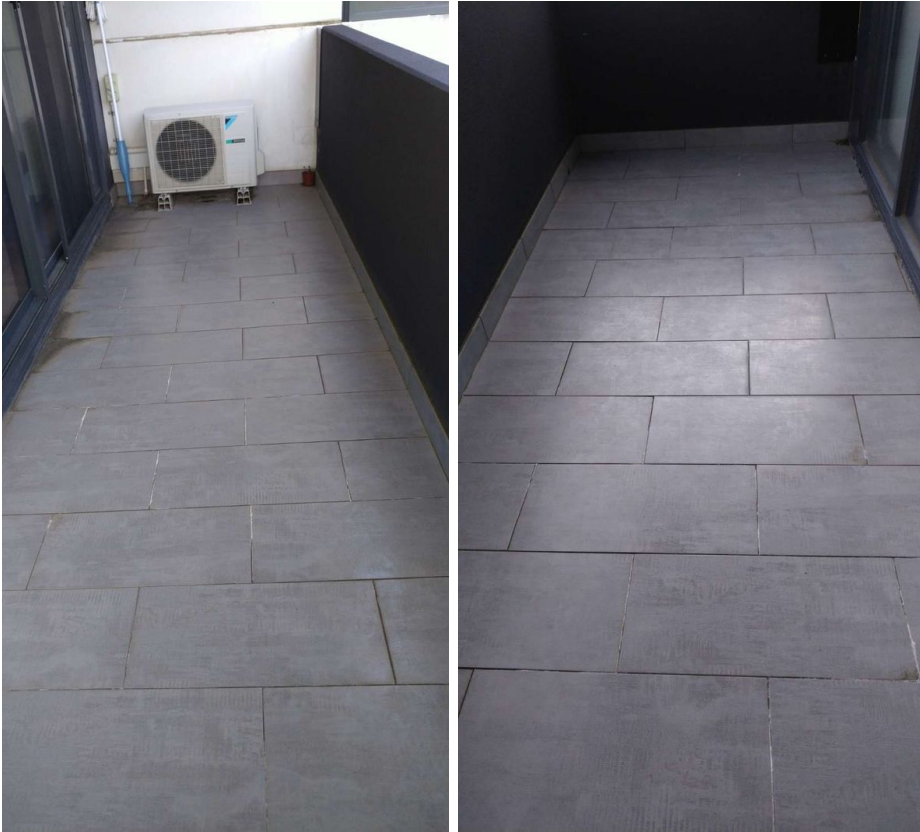
Floor Condition: In serviceable condition at time of inspection

Monitoring and maintenance is required for grout and caulking areas of tiled floors to maintain no water entry below

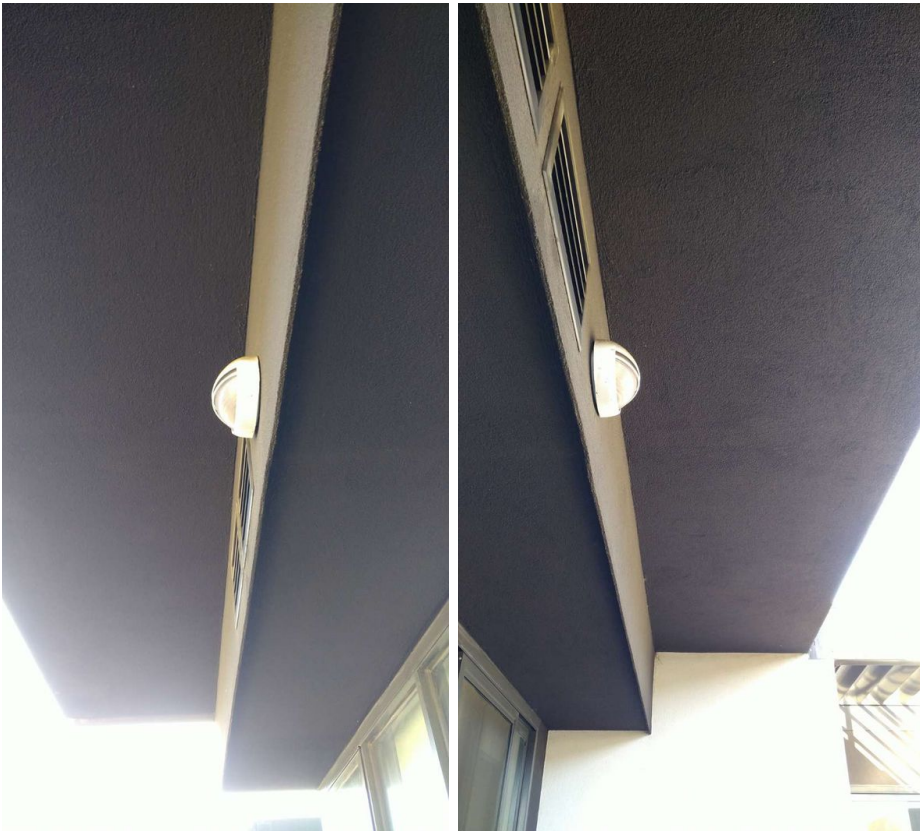
Roofing Condition: In serviceable condition at time of inspection

Note these areas are susceptible to heavy punishment during storms and bad weather
