BUILDING REPORT

1234 Main Street

Pre-purchase property condition report

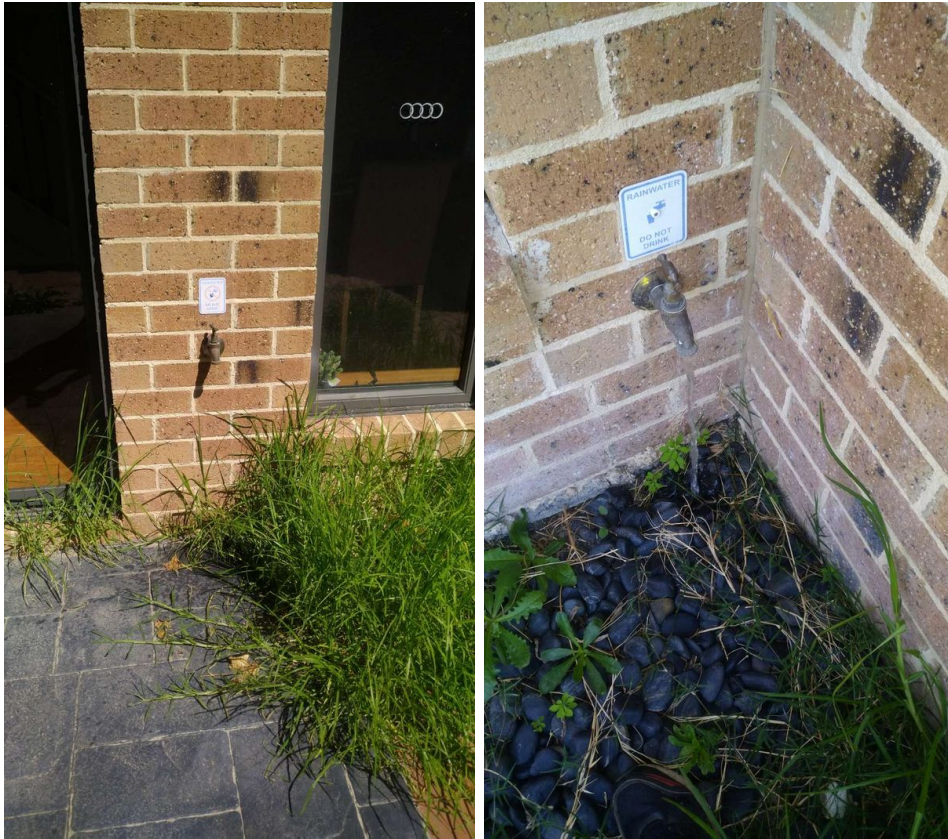
NO TAP DRAIN

Recommend installing a tap drain. Excess water around the slab edge becomes a conducive condition for termites.
