LEADING BUILDING & PEST INSPECTIONS

BUILDING REPORT COPY

TEST ST
5000

Pre-purchase property condition
report

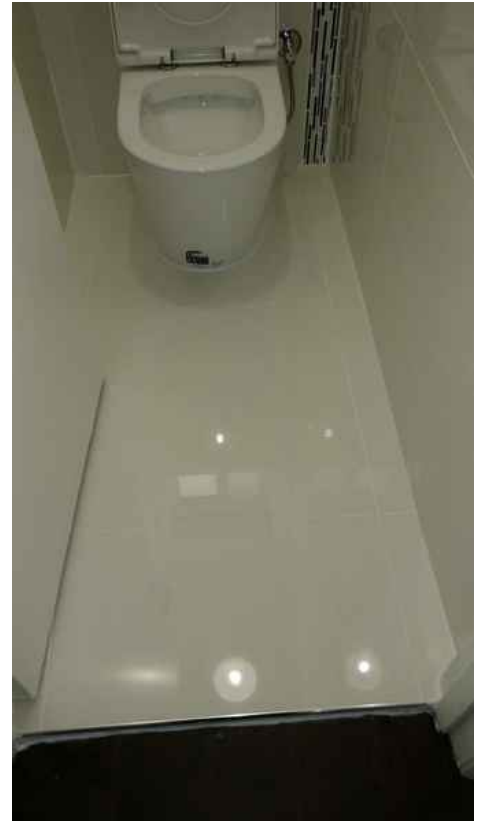
Toilet Condition: In serviceable condition at the time of inspection

Toilet functioned as intended
