# LEADING BUILDING & PEST INSPECTIONS

## BUILDING REPORT COPY

1234 test st.  
80122

Pre-purchase property condition  
report

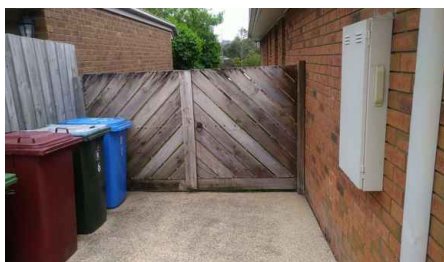
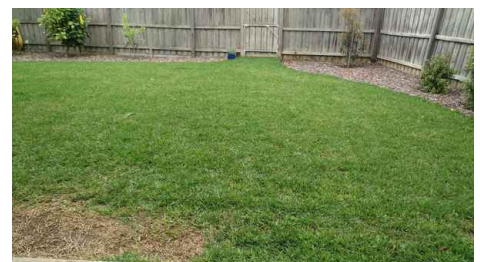
**Lot Grade and Drainage : Moderate Lot Grading**

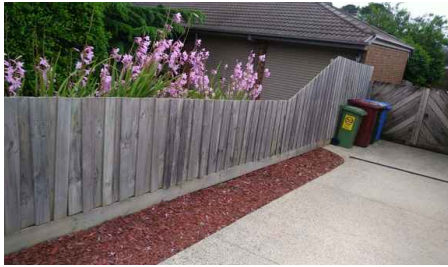
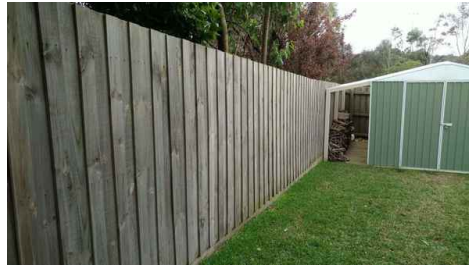
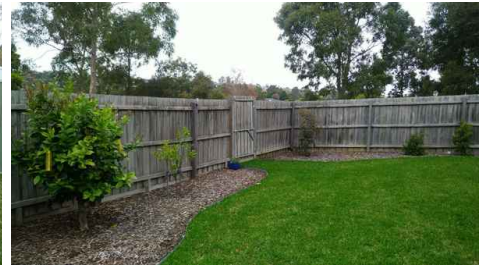
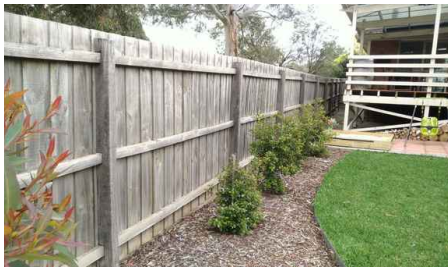
**Fences: In serviceable condition at time of inspection**

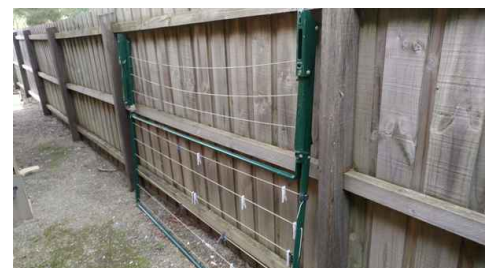
**DETACHED LOTHES LINE PRESENT.**

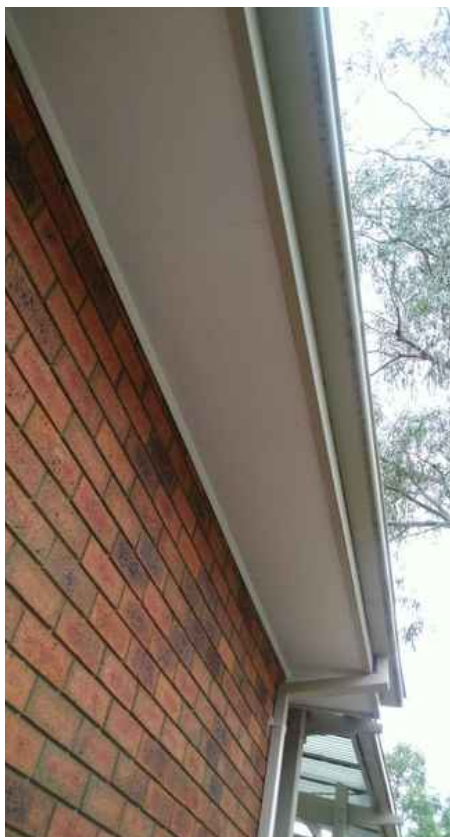
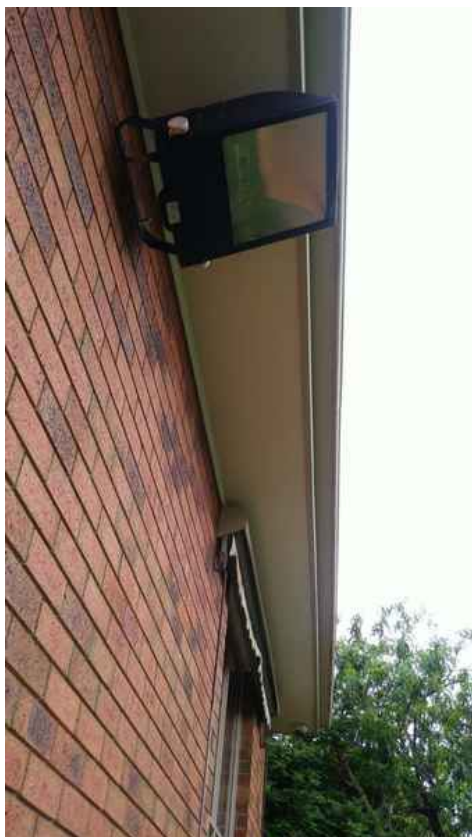
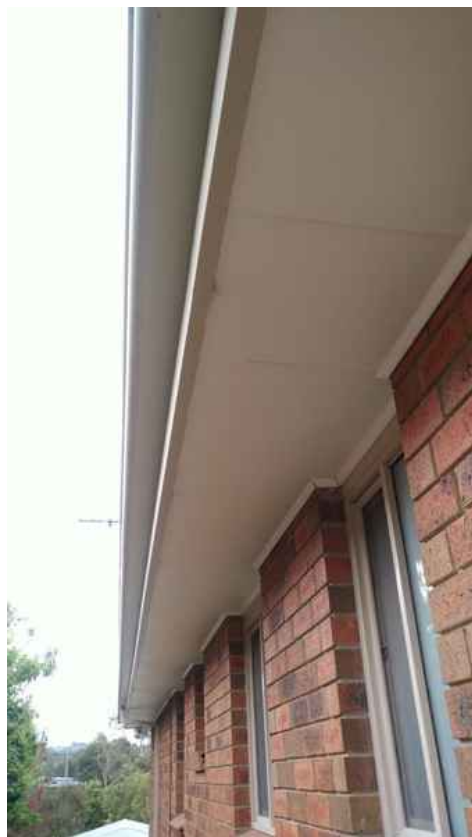
**Eave/Soffit linings: In serviceable condition at the time of inspection**

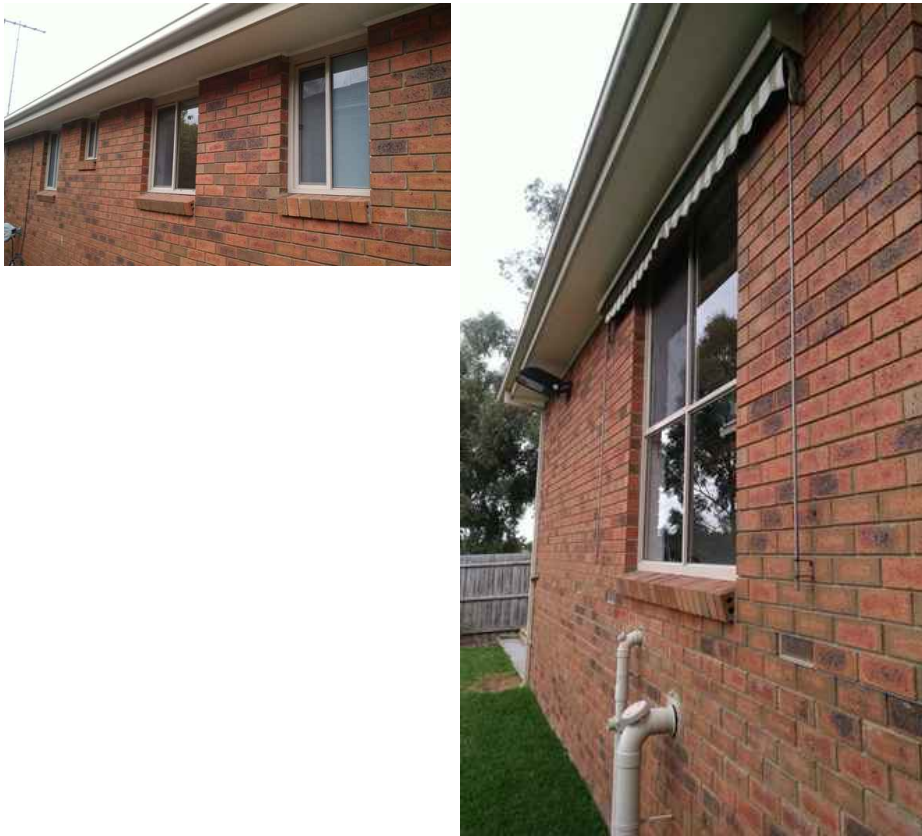
**Window/Frames: Windows generally In serviceable condition at time of inspection**

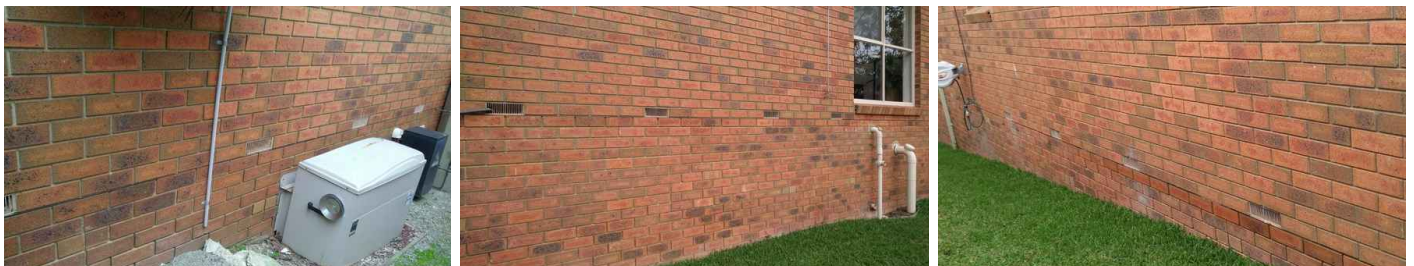
**Weep holes/Vents: Found to be in serviceable condition at the time of the inspection**

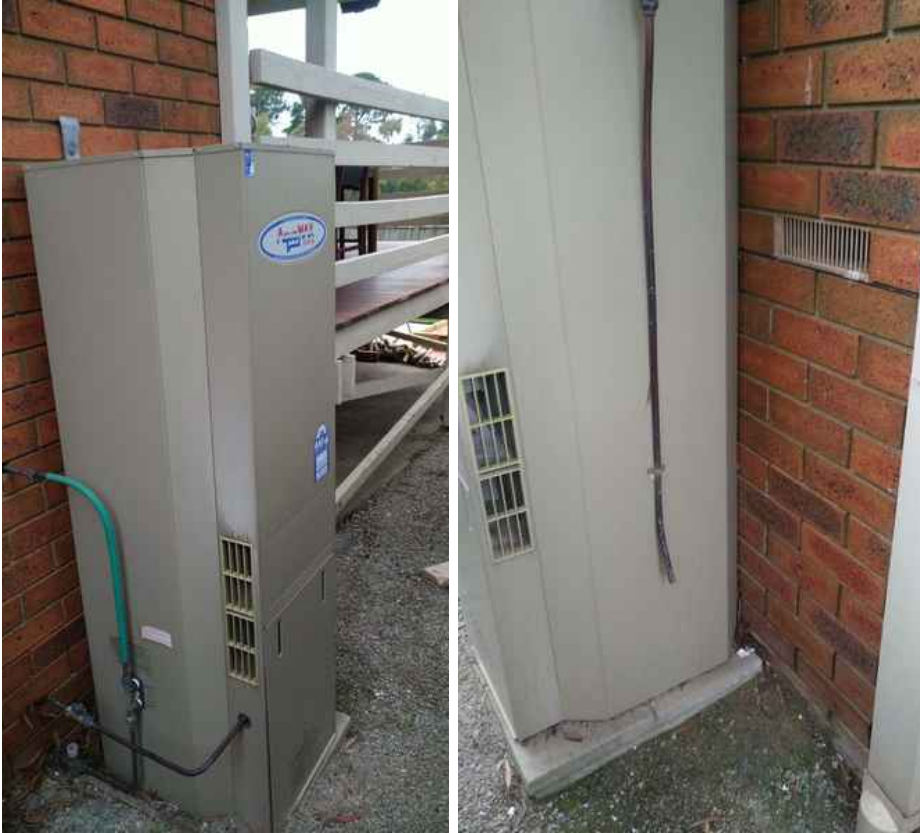
**Hot Water Unit/s: Instant gas wall unit**

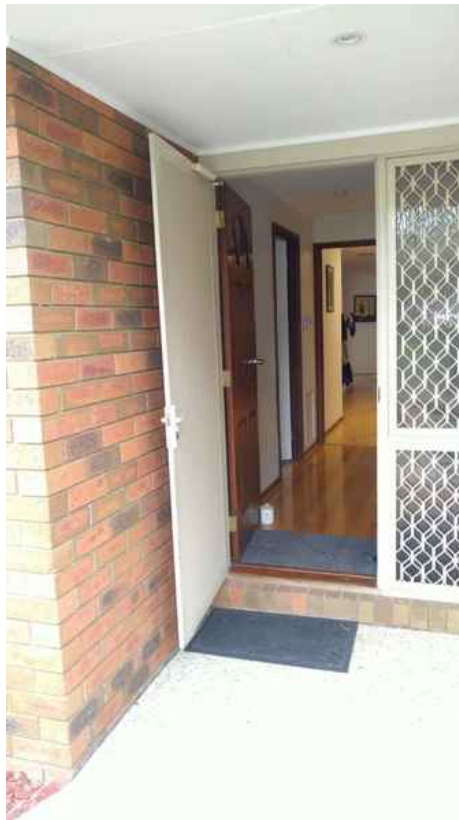
**Door(s) Condition:** In serviceable condition at the time of inspection

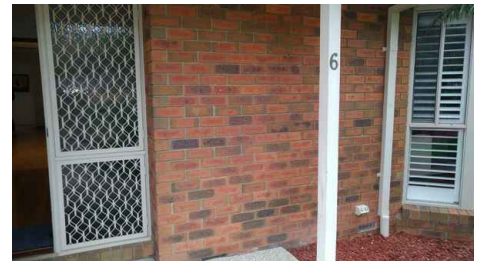
**Wall Condition:** In serviceable condition at the time of inspection

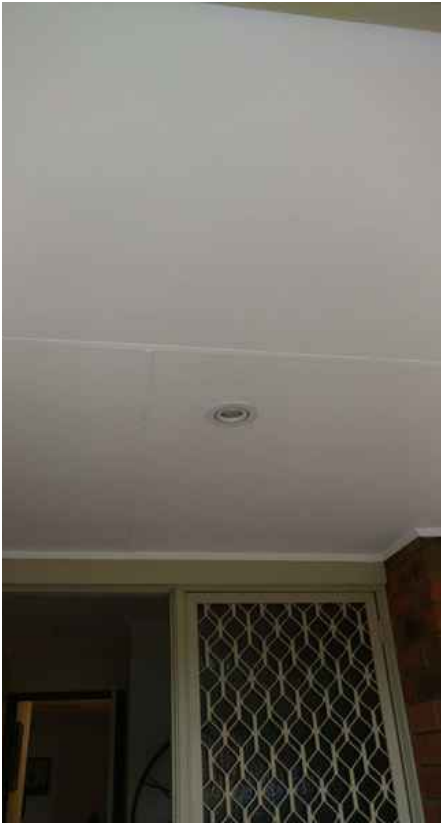
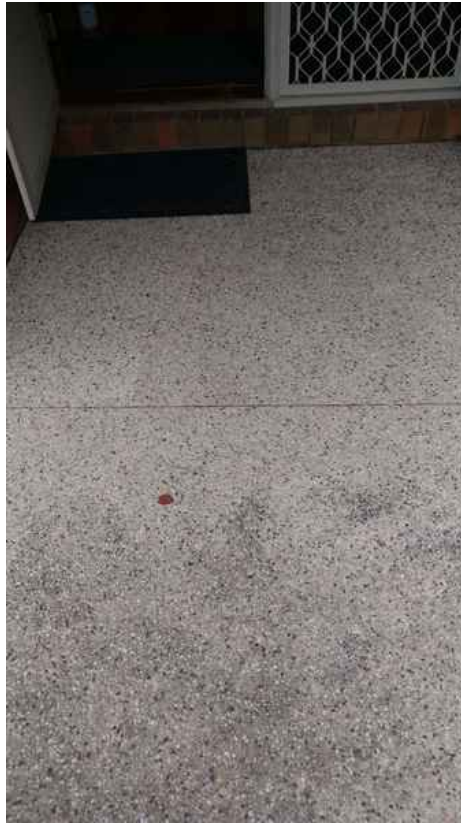
**Floor Condition:** In serviceable condition at the time of inspection

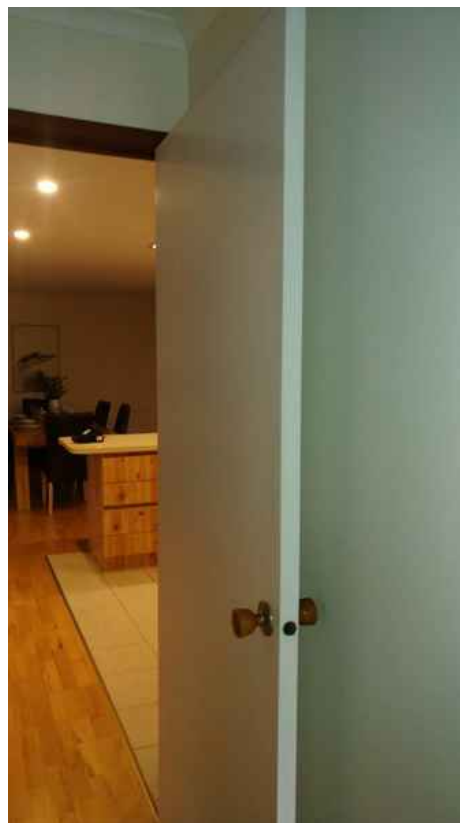
#### Door(s) Condition: In serviceable condition at the time of inspection

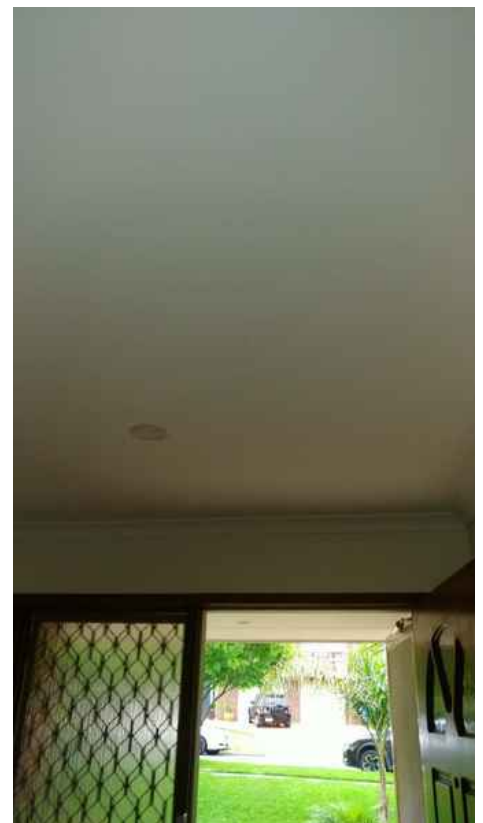
#### Ceiling Conditions: In serviceable condition at time of inspection

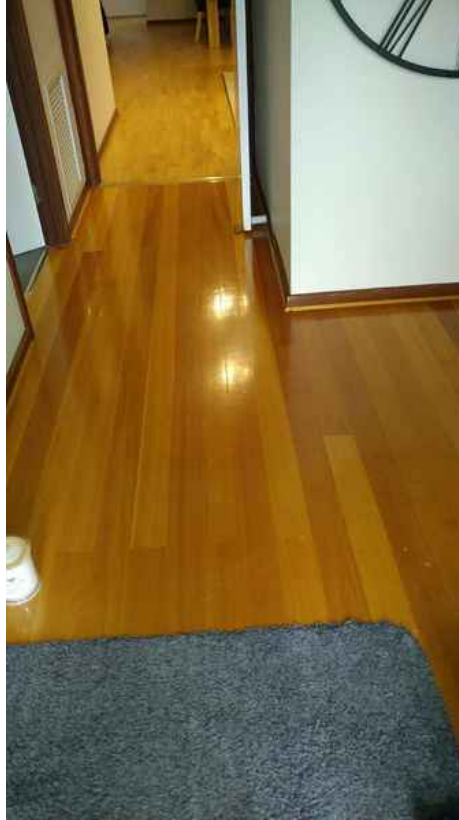
**Floor Condition: In serviceable condition at time of inspection**

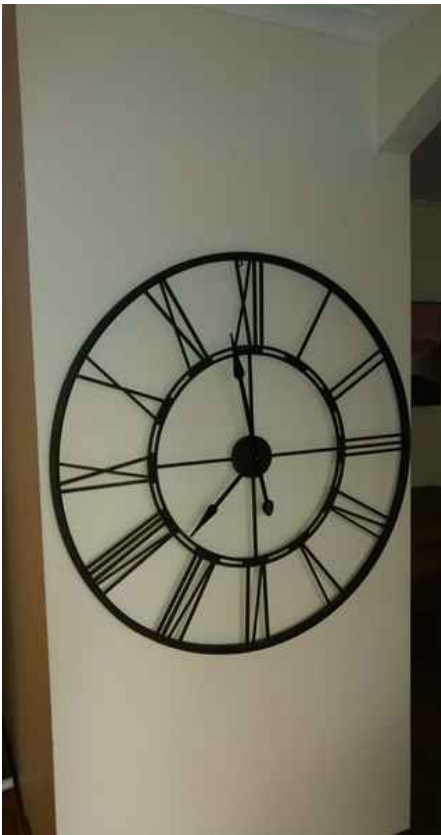
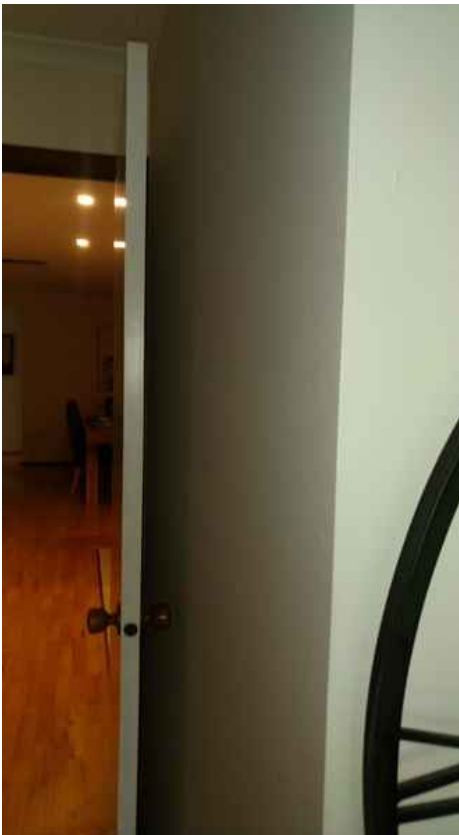
**Wall Condition: In serviceable condition at the time of inspection**

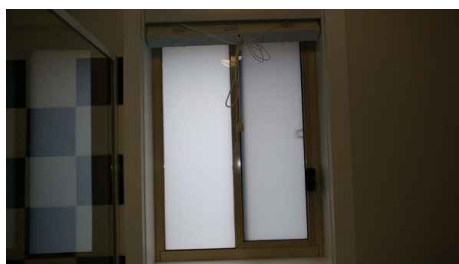
**Window/s: In serviceable condition at the time of inspection**

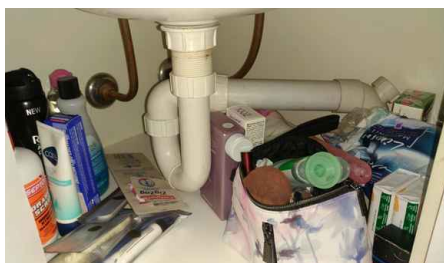
**Waste Water Trap/s Condition: In serviceable condition at the time of inspection**

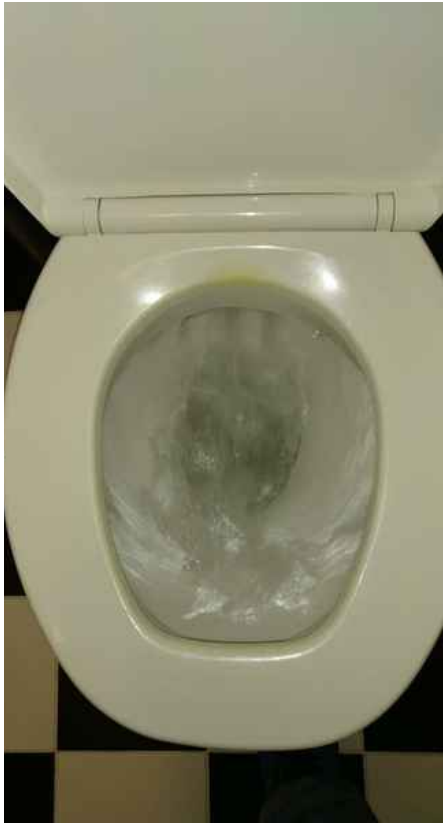
**Toilet Condition: In serviceable condition at the time of inspection**

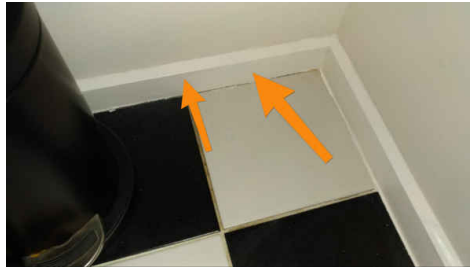
7.5.1 Floor condition

**DAMAGED GROUT/MASTIC OBSERVED**

suggest re-grouting/sealing as necessary to prevent water damage.

Contact a qualified tile contractor

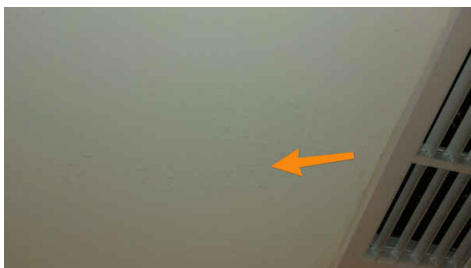
8.4.2 Ceiling Conditions

**PEELING PAINT OBSERVED**

DEFECT

Contact a qualified professional.

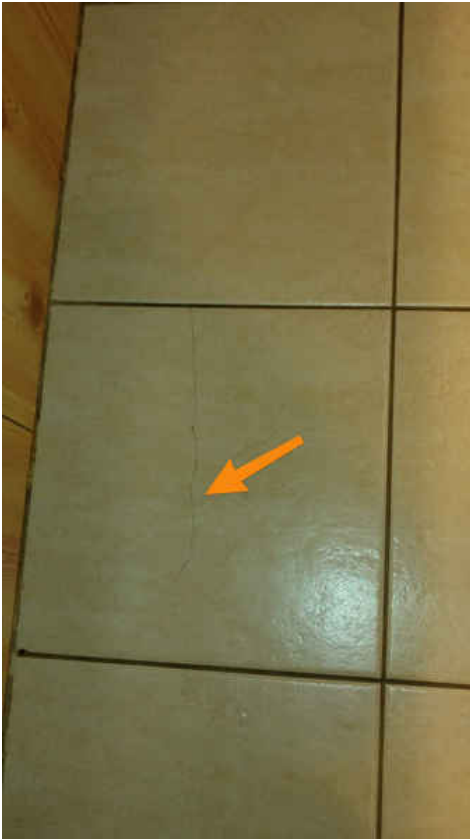
### 9.5.1 Floor Condition

**CRACKED TILES NOTED**

Likely caused by impact or defective tile

MAINTENANCE/MONITOR

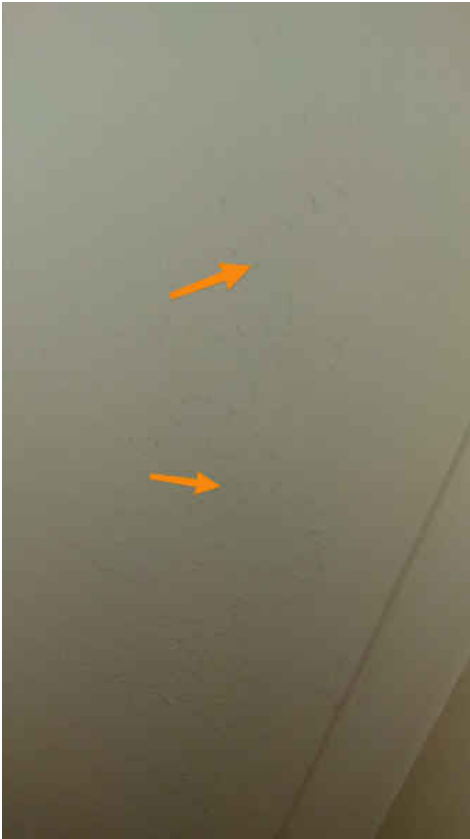
### 11.4.1 Ceiling Conditions

#### **PEELING PAINT OBSERVED**

Contact a qualified professional.

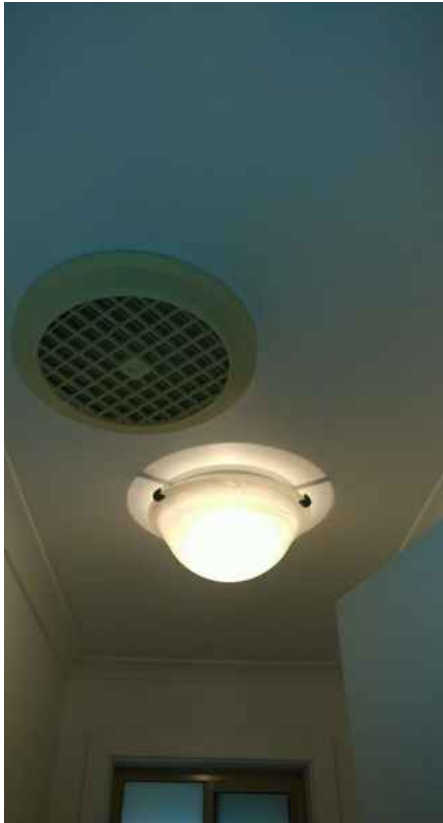
**Ceiling Condition:** In serviceable condition at time of inspection

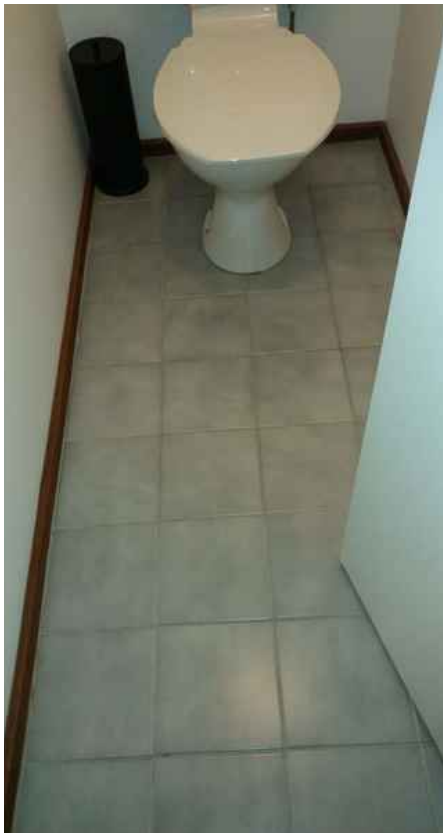
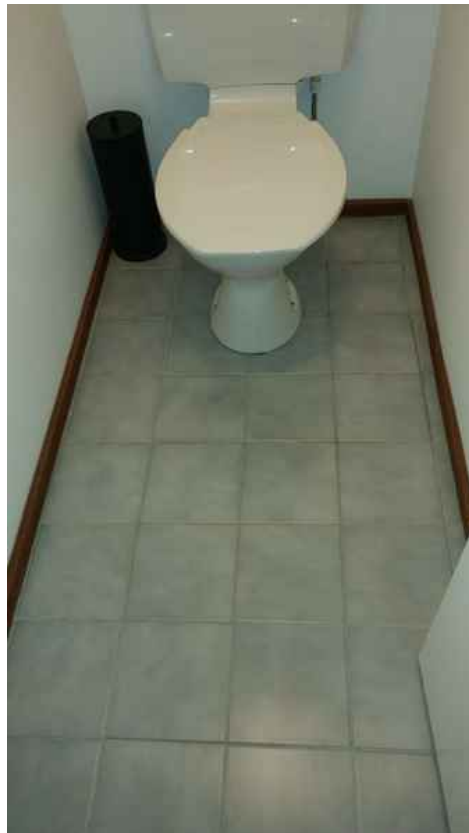
**Floor Conditions:** In serviceable condition at time of inspection

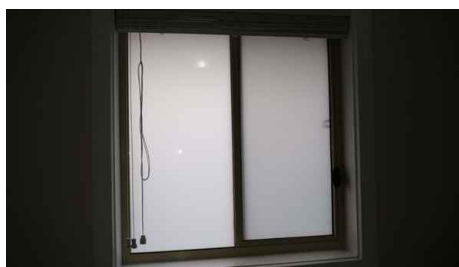
### Window(s): In serviceable condition at time of inspection

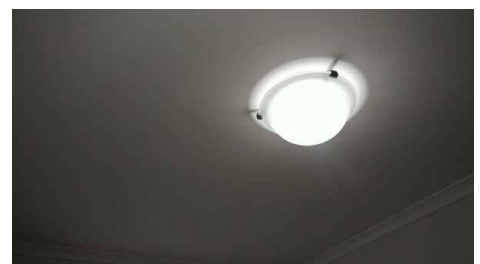
### Ceiling(s) Condition: In serviceable condition at time of inspection

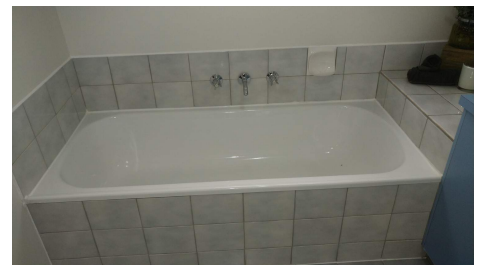
**Bath surround: In serviceable condition at time of inspection**

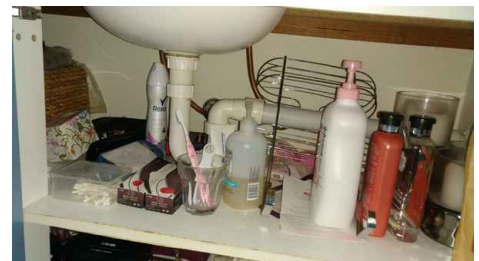
**Waste Water Trap/s Condition: In serviceable condition at time of inspection**

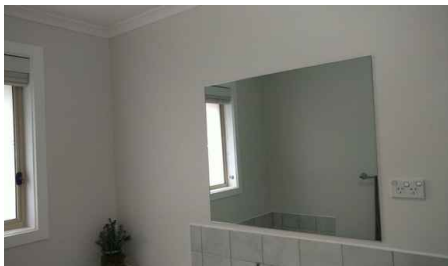
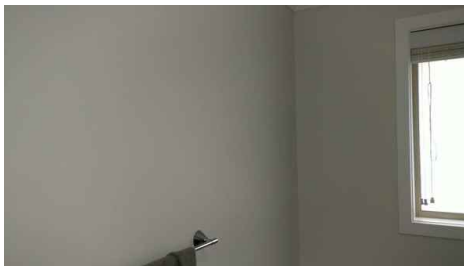
**Walls Condition: In serviceable condition at the time of inspection**

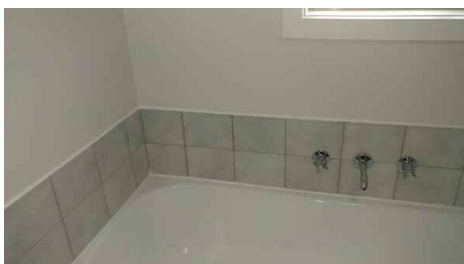
**Splashback: In serviceable condition at time of inspection**

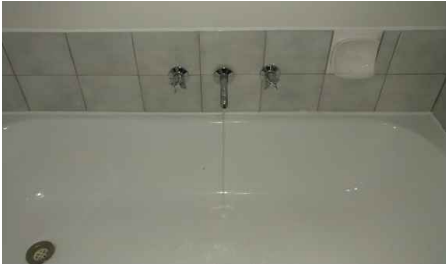
### Tap(s) Condition: Tap Function

Operated and appeared serviceable at time of inspection. No warranty or guarantee given to future performance.

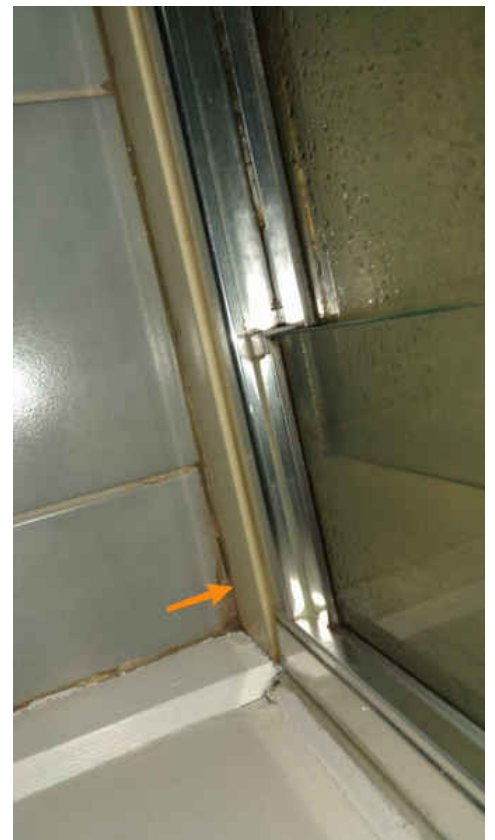
### 13.5.1 Floor condition

#### **DAMAGED/DETERIORATED GROUT/MASTIC OBSERVED**

All missing/damaged grouting/caulking should be replaced. Failure to keep walls sealed can cause deterioration and extensive moisture damage to the interior walls and surrounding sub-flooring. This damage is not always visible or accessible to the inspector at the time of inspection.

Contact a qualified tile contractor

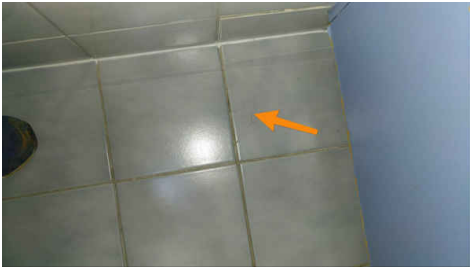
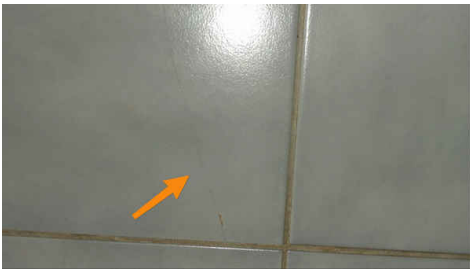
### 13.5.2 Floor condition

#### **CRACKED TILE(S) NOTED**

Cracked tiles are common often caused by minor underlining structural movement. Consider replacement or updating to restore visual appearance.

Contact a qualified tile contractor

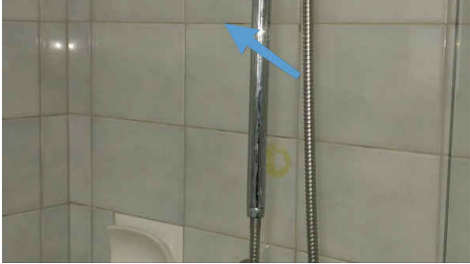
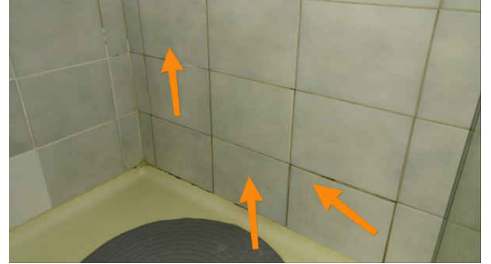
13.7.1 Shower Base Condition

**MISSING/DETERIORATED GROUT**

Missing/damaged grout noted throughout the tiled base. Recommend maintenance of grout and sealant to prevent water seepage and damage to the floor.

Contact a handyman or DIY project

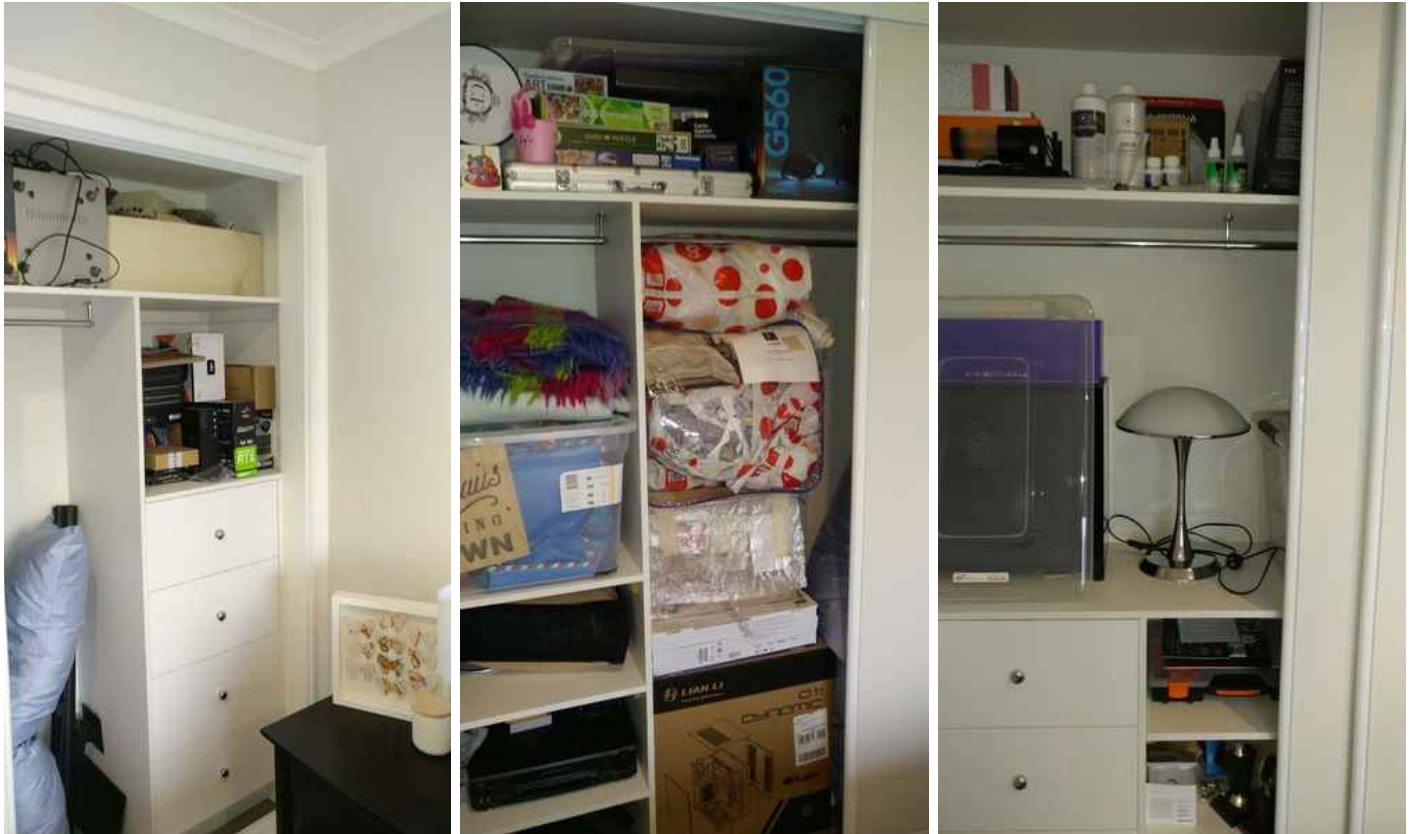
**Robe/Cupboard: In serviceable condition at the time of inspection**

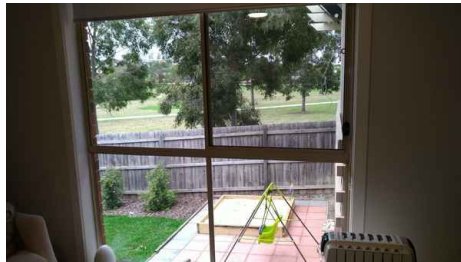
### Window(s) Condition: In serviceable condition at the time of inspection

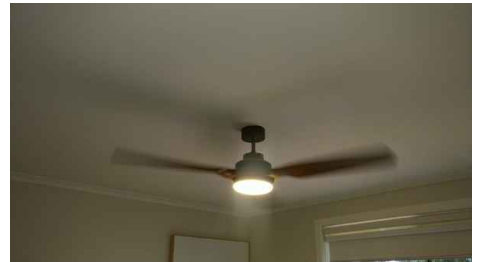
### Ceiling(s) Condition: In serviceable condition at the time of inspection

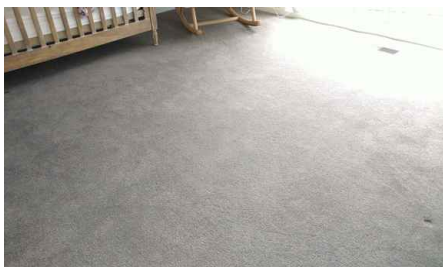
### Floor(s) Condition: In serviceable condition at the time of inspection

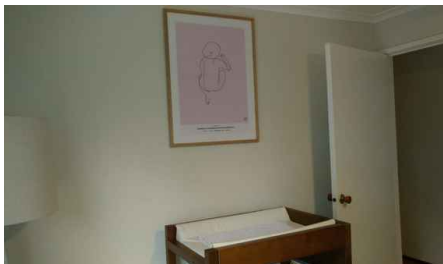
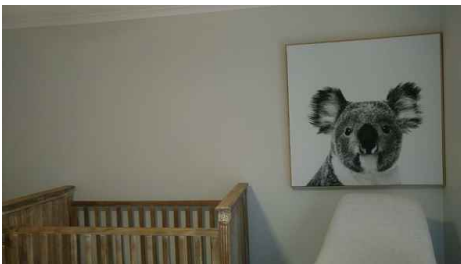
### Wall Condition: In serviceable condition at the time of inspection

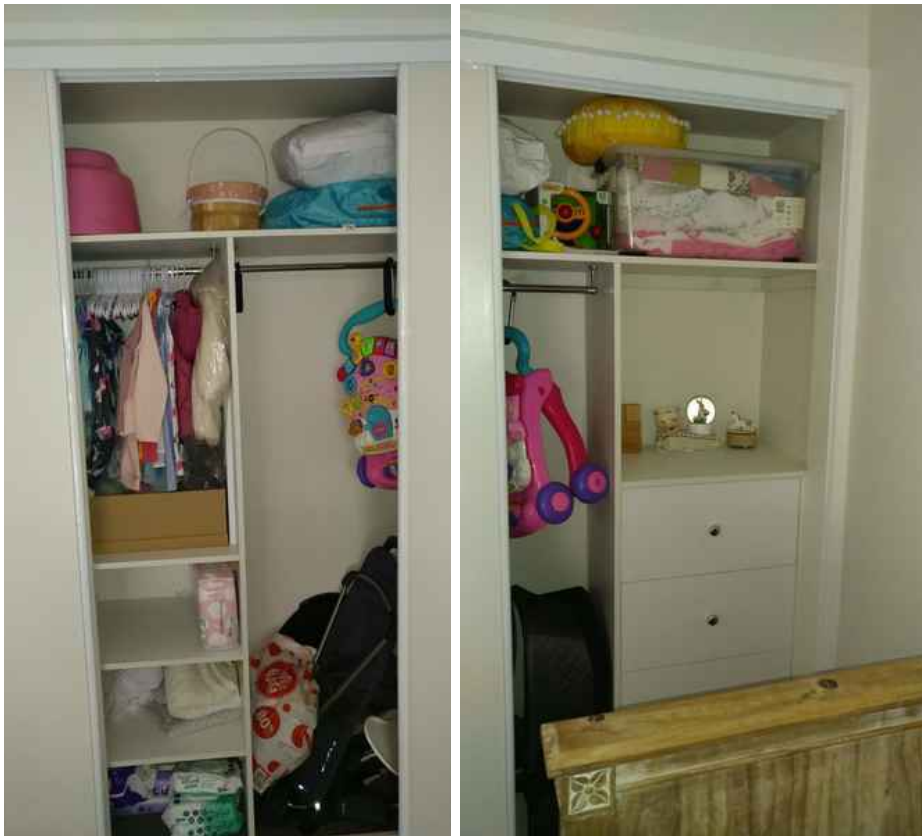
**Robe/Cupboard: In serviceable condition at the time of inspection**

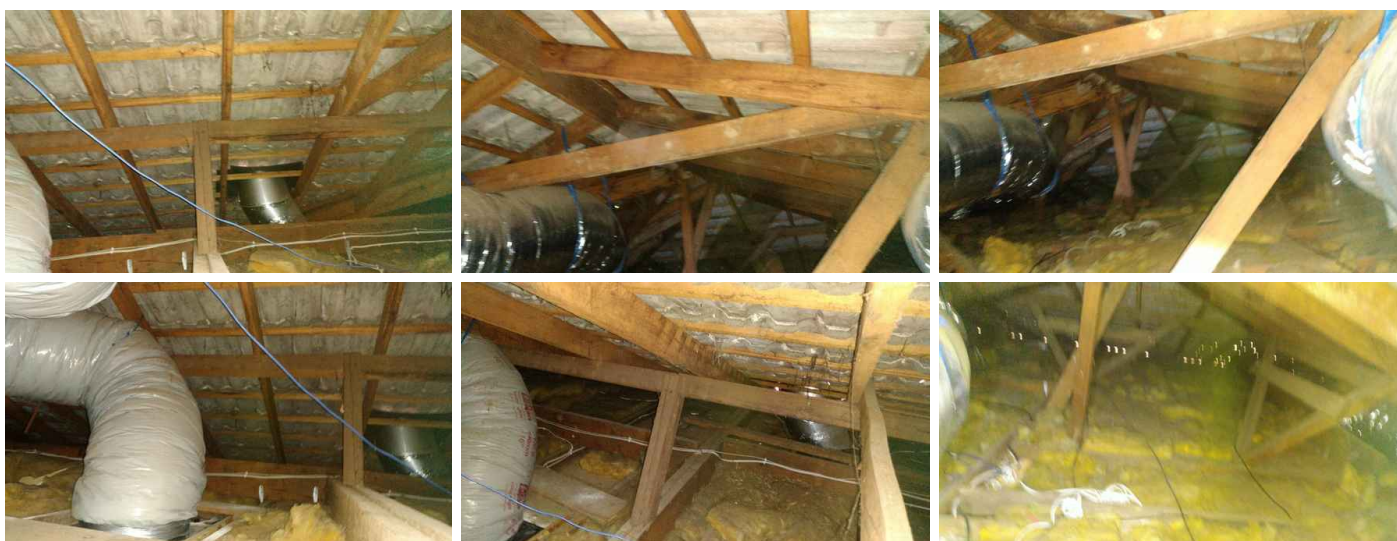
### Roof Cladding Underside : Roof cladding appeared to be in serviceable condition

Please note. Not all areas are visible to the inspector, buyer needs to be aware these areas may contain hidden defects and these areas and items are excluded from the report. Requesting information from the vendor About known issues with the roof cladding is recommended.

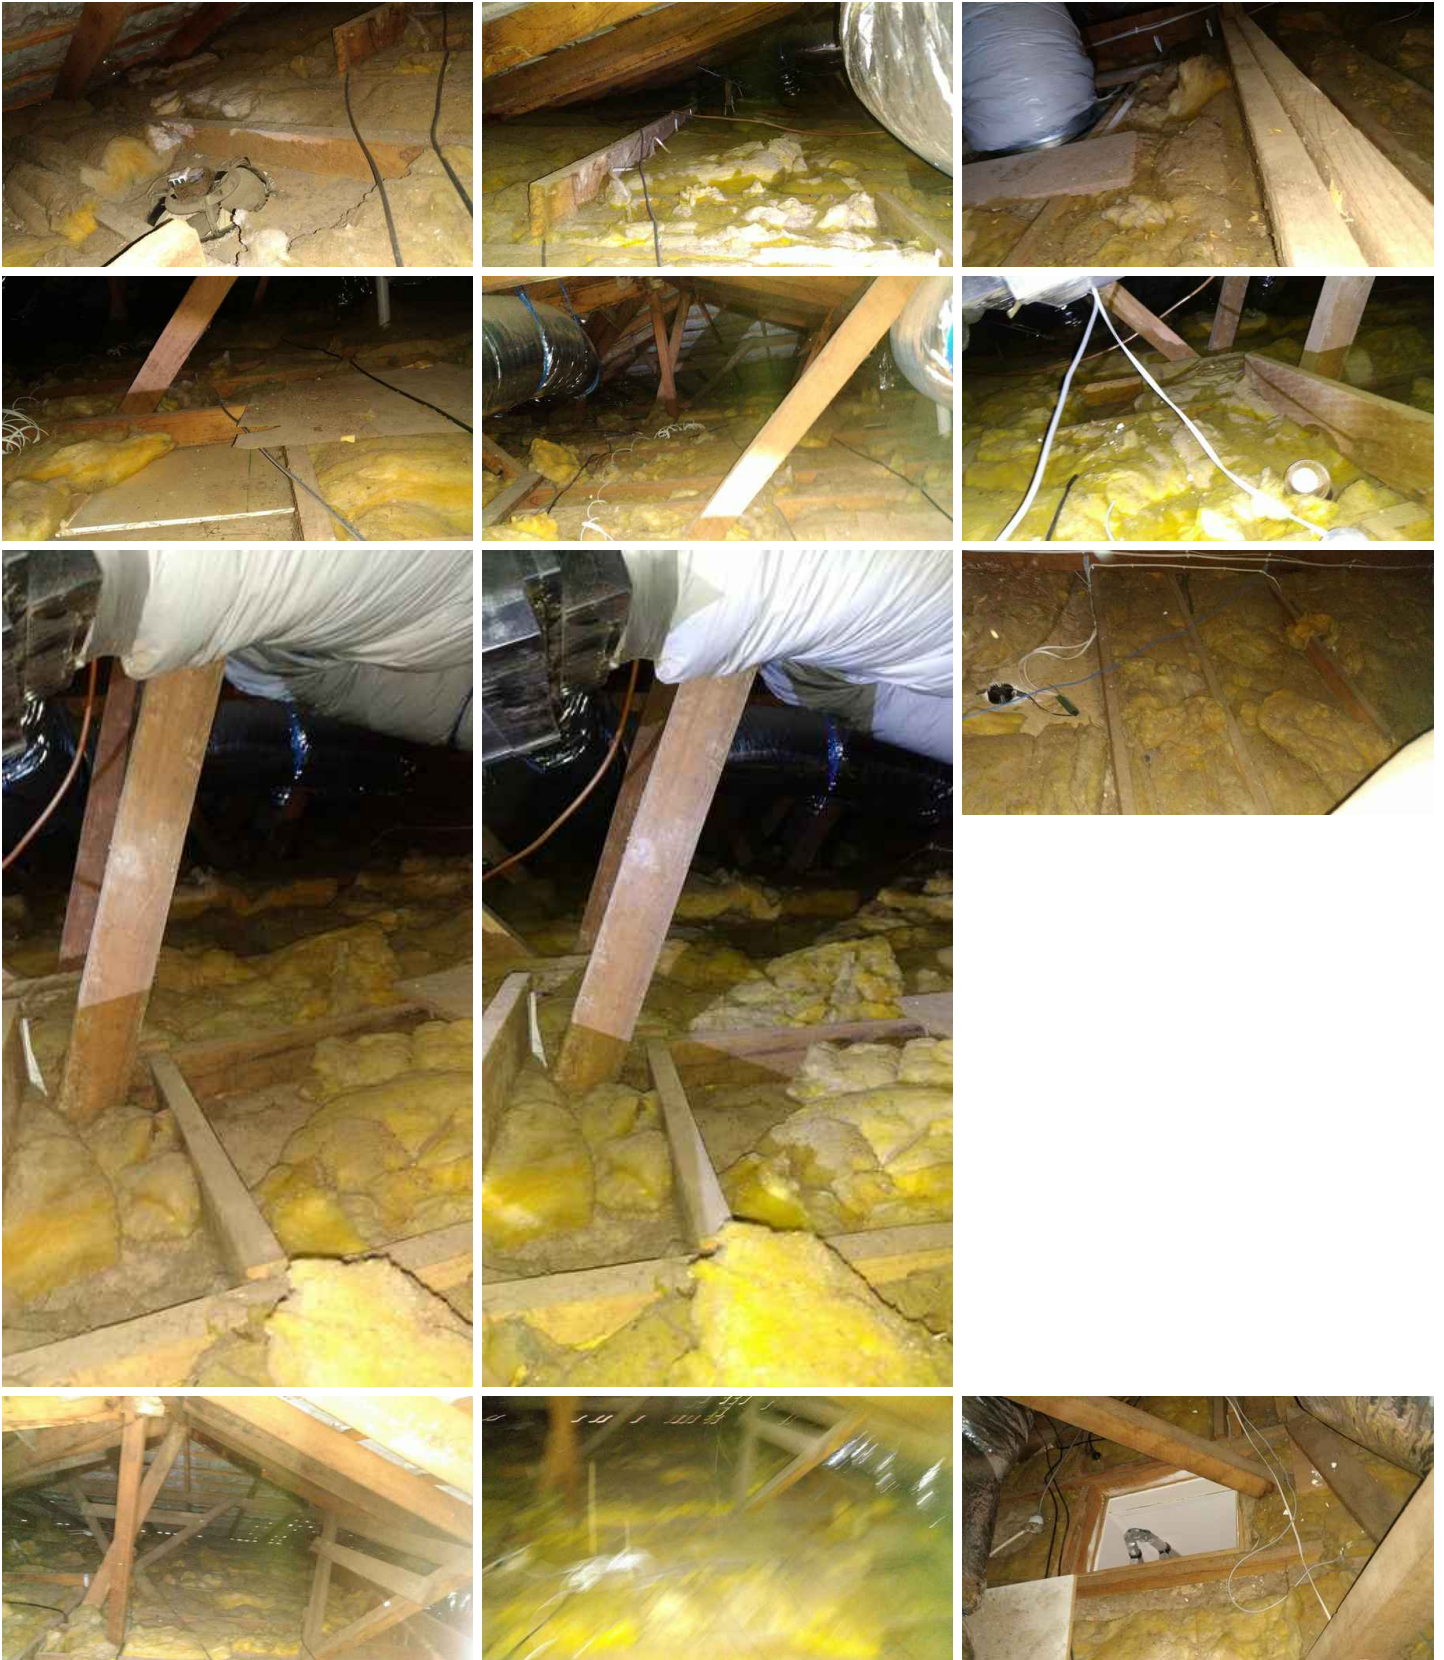
17.5.1 Ventilation

Kitchen and/or bathroom vent fans are improperly venting into attic/roof void. Recommend extending fan exhaust to the exterior to prevent damage and/or deterioration from moisture and/or condensation.

**KITCHEN/ OR BATH EXHAUST  
VENTS DIRECTLY INTO ROOF SPACE**

Not recommended should be vented externally to ensure dirty air does not attract vermin to ceiling space.

Or whirleybird recommended

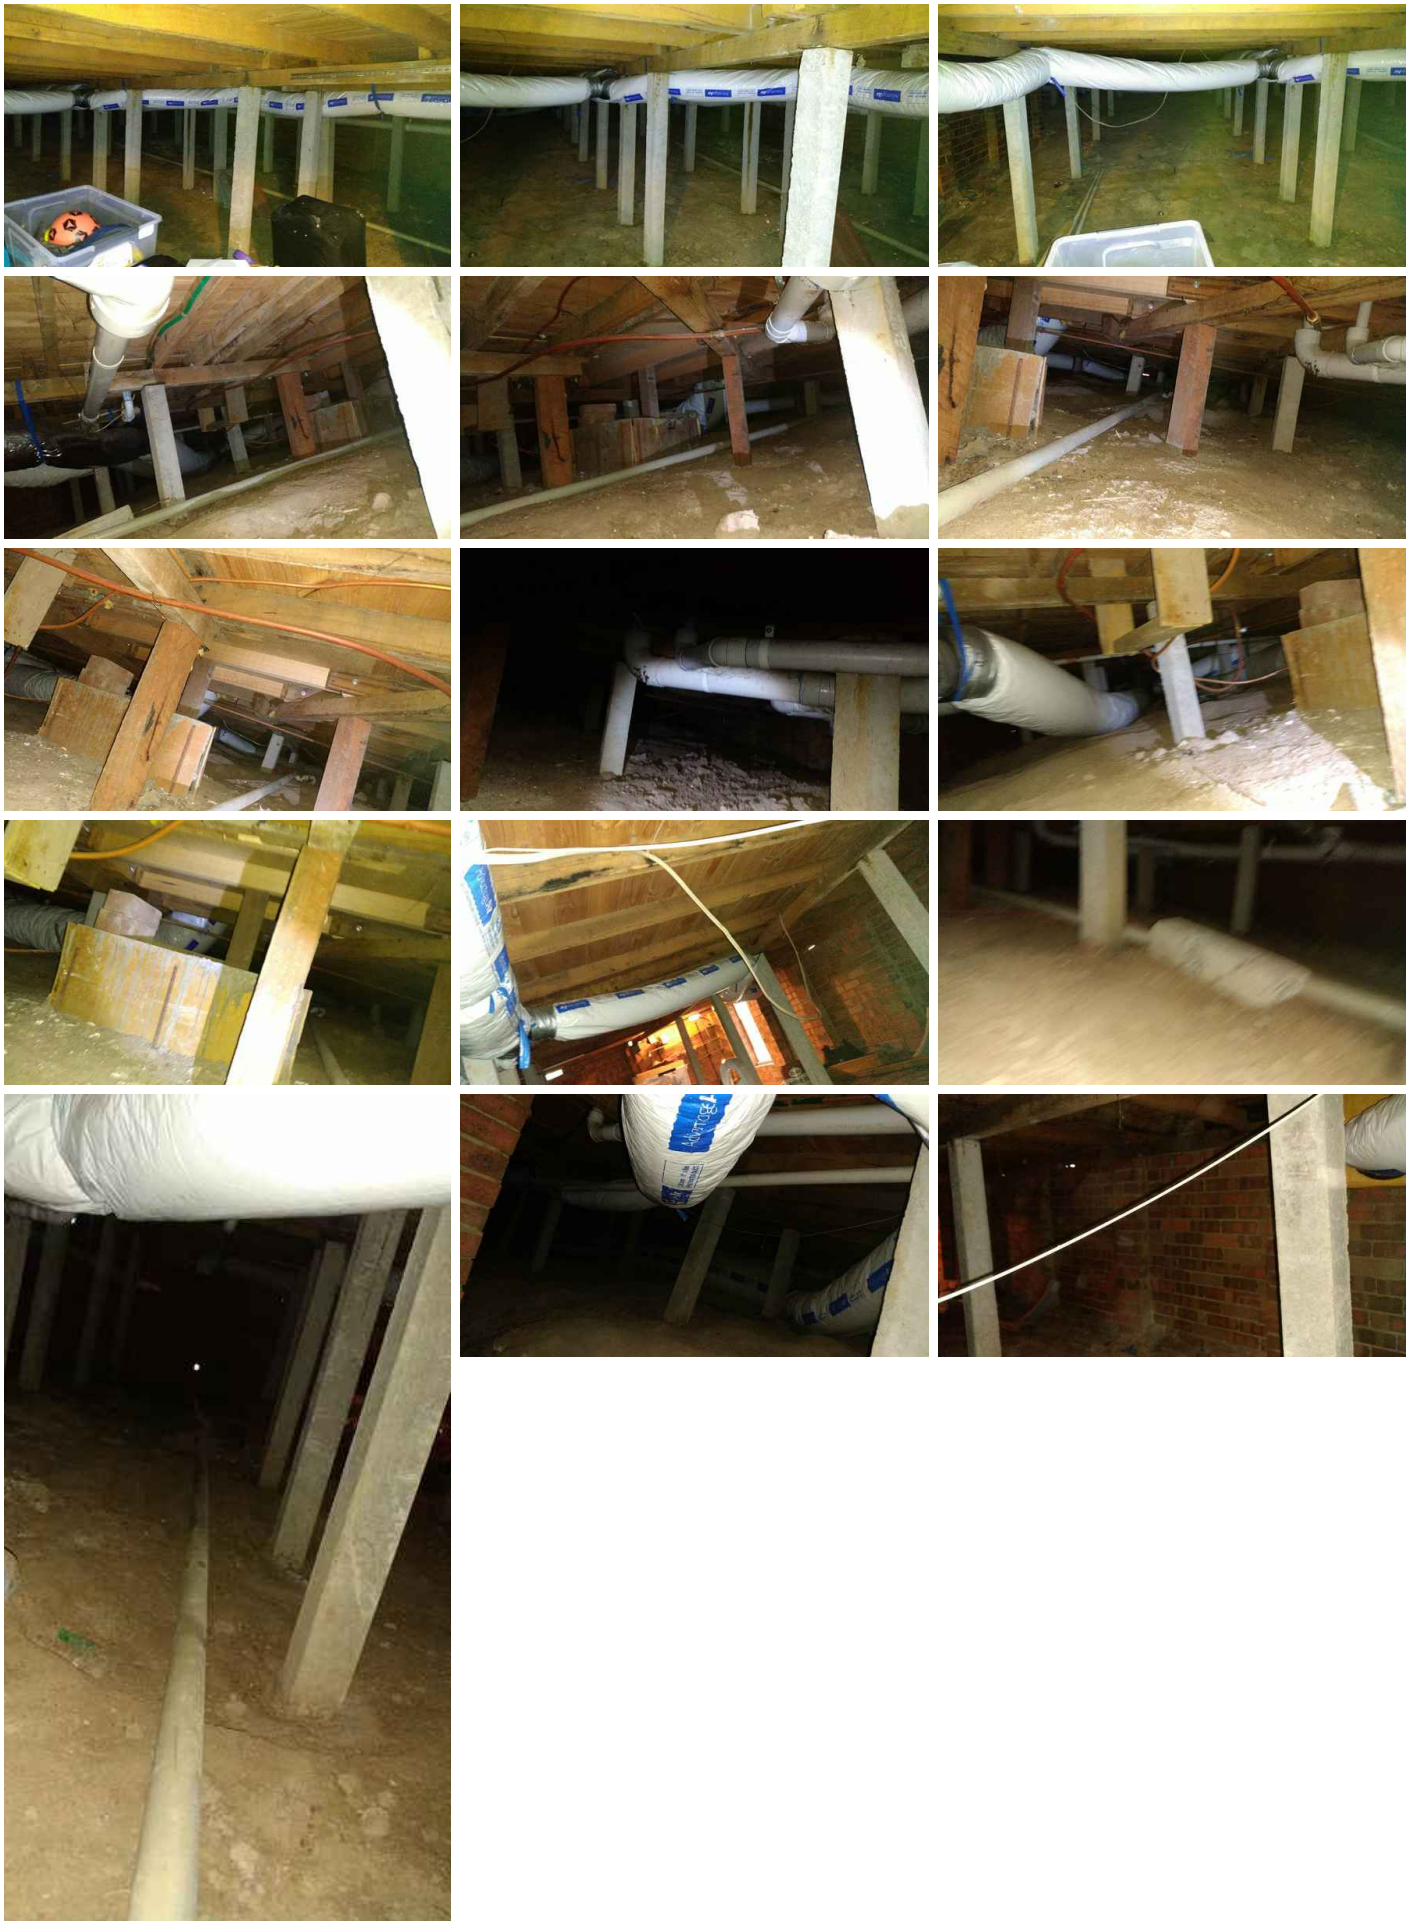
**Support Post/stumps Comments: In serviceable condition at time of inspection**

Ant capping are installed to deter termites forcing them to build their mud tubs around the ant capping enabling detection during inspection. Regular pest inspection is recommended.

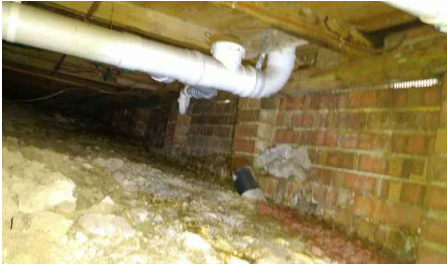
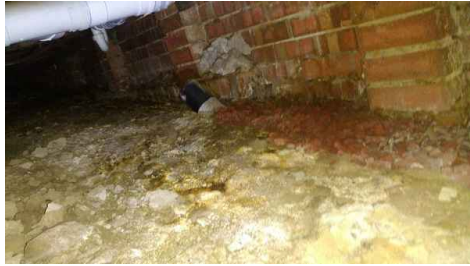
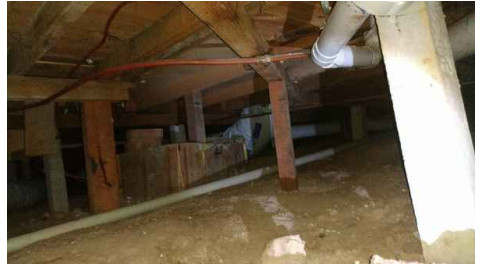
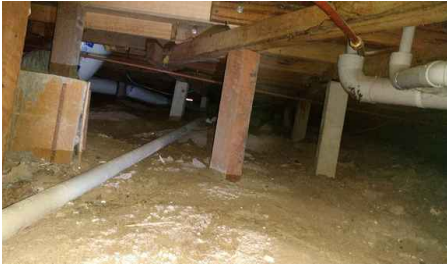
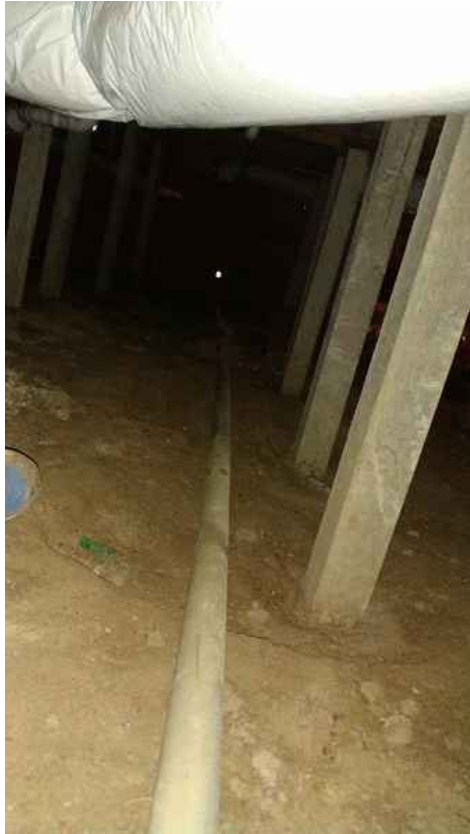
**Crawlspace Floor Condition: In serviceable condition at time of inspection**

Relatively dry at time of inspection

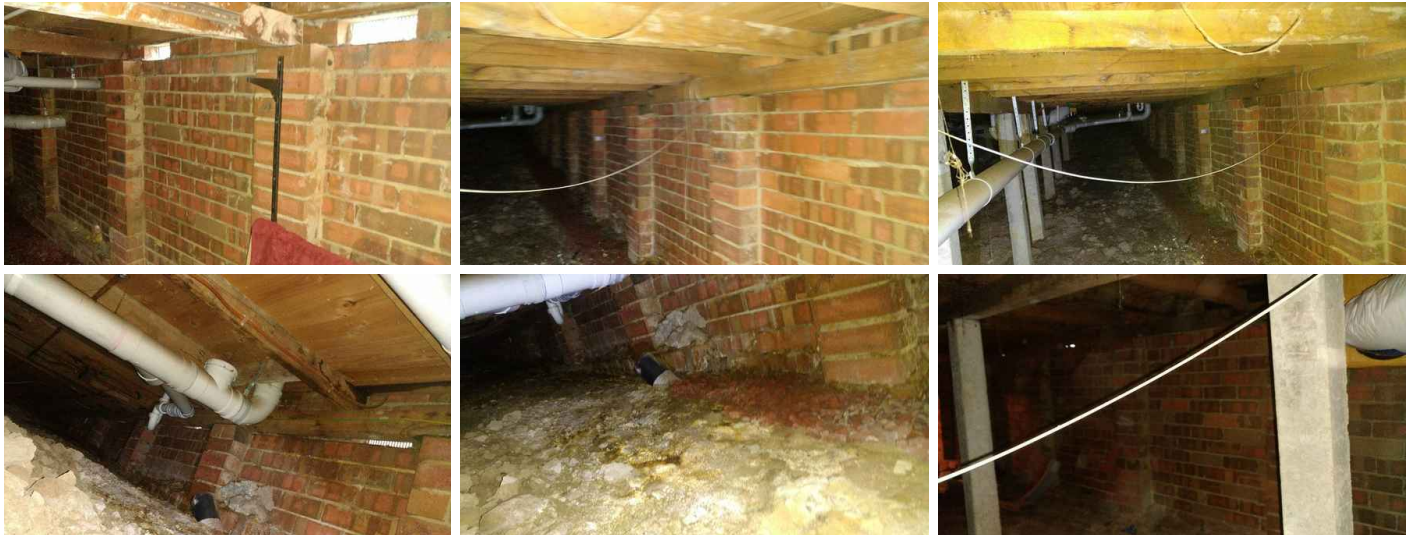
**Crawlspace Walls Condition: In serviceable condition at time of inspection**
