# LEADING BUILDING & PEST INSPECTIONS

## BUILDING REPORT COPY

1234 test st.  
80122

Pre-purchase property condition  
report

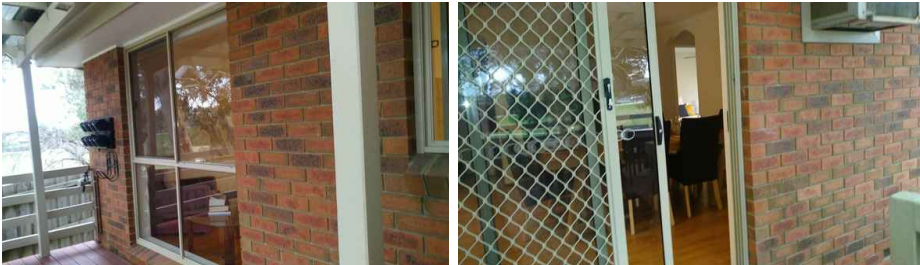
**Wall Condition:** In serviceable condition at the time of inspection

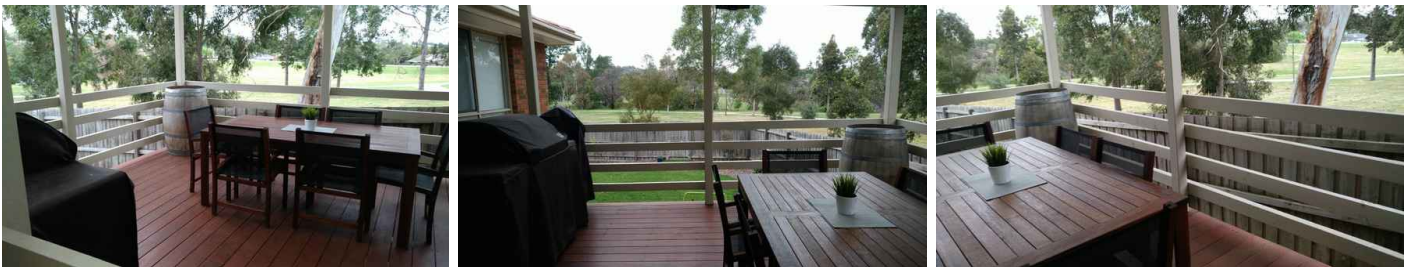
**Balustrade:** In serviceable condition at the time of inspection

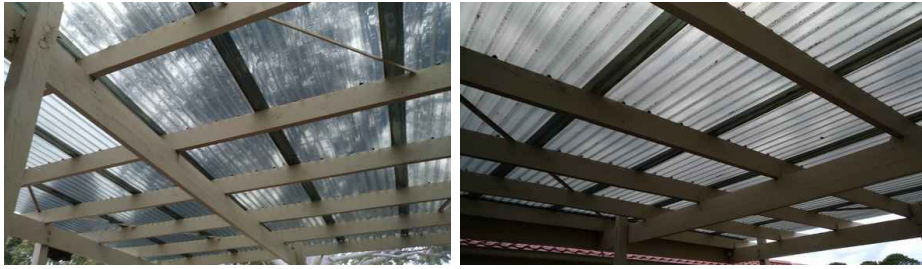
**Ceiling Condition: In serviceable condition at the time of inspection**

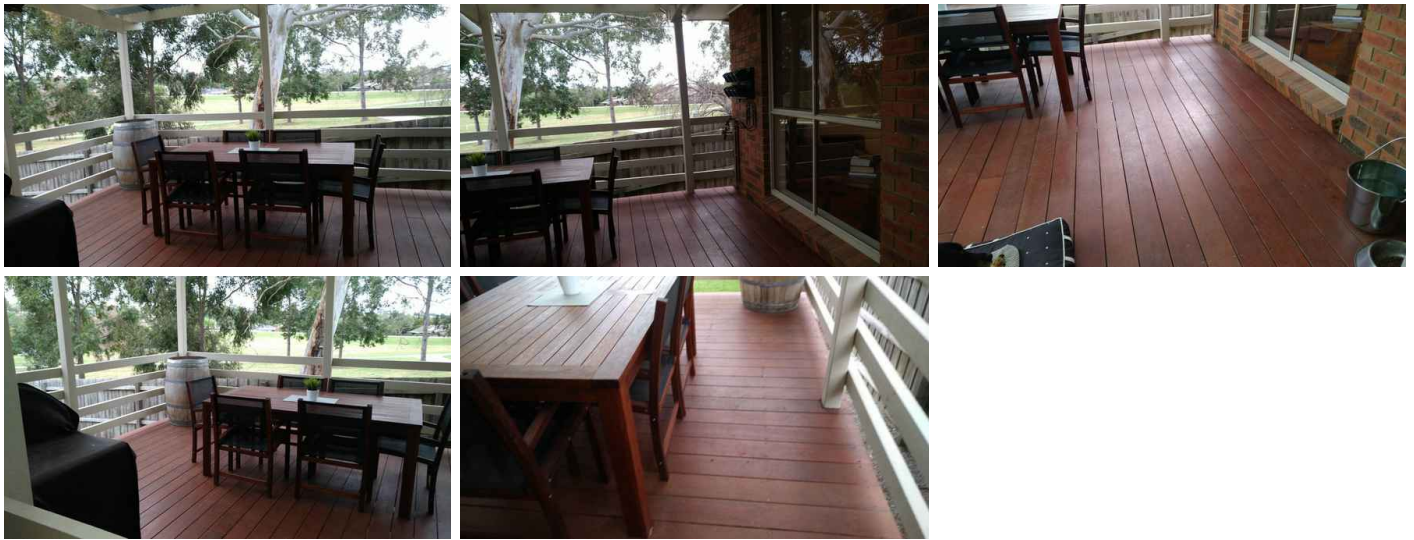
**Floor Condition: In serviceable condition at the time of inspection**
