LEADING BUILDING & PEST INSPECTIONS

BUILDING REPORT COPY

TEST ST
5000

Pre-purchase property condition
report

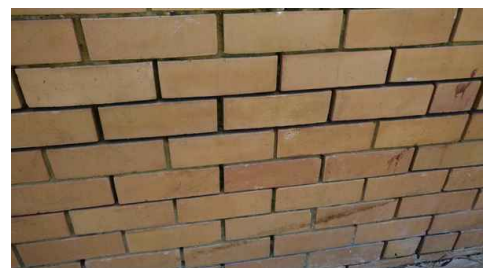
Mortar eroding

DETERIORATED MORTAR OBSERVED

Recommendation: contact a licensed brick layer/stone mason to evaluate.

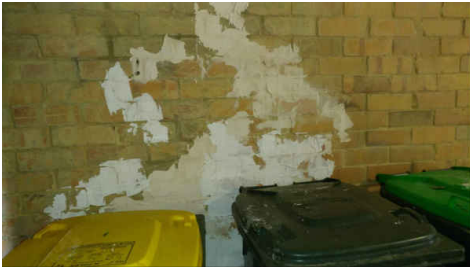
- 🔧 4.1.1 Attached Garage - Under main roof - Wall Condition: Evidence of repairs observed
- 🔧 4.1.2 Attached Garage - Under main roof - Wall Condition: Defect - Significant CRACKS noted

Contact a handyman or DIY project

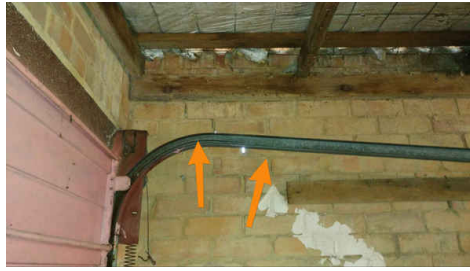
4.2.1 Ceiling Lining Condition

MAIN SUPPORT BEAM IS DECAYED AND WILL REQUIRE REPAIRS/REPLACEMENT

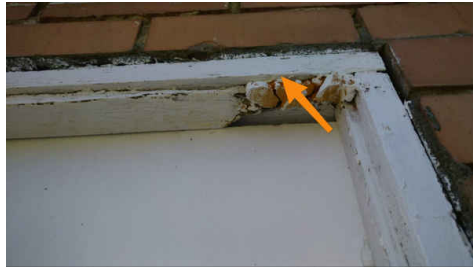
- 🔧 4.6.1 Attached Garage - Under main roof - Personal Access Door Condition: Hardware is damaged
- ⊖ 5.1.1 Site/Grounds - Driveway : Cracking and/or heaving to driveway noted

Contact a qualified door repair/installation contractor.

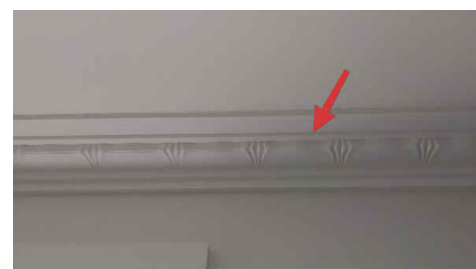
9.4.1 Ceiling Conditions

COMMON CRACKING

These are cosmetic by nature usually from minor substrate movement. Recommend repair and repaint to enhance cosmetic appearance.

Contact a handyman or DIY project

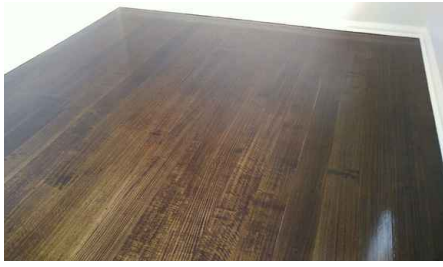
Floor(s) Condition: In serviceable condition at the time of inspection

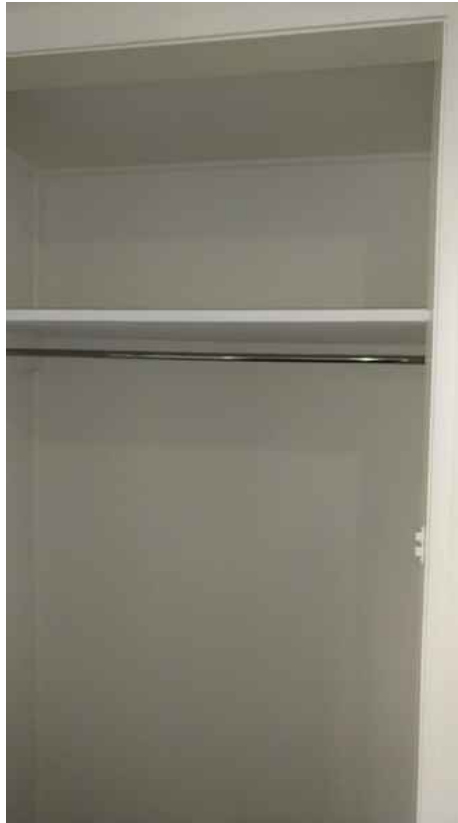
Robe/Cupboard: In serviceable condition at the time of inspection

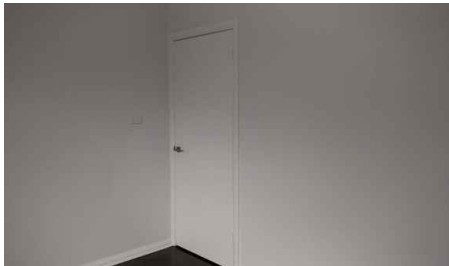
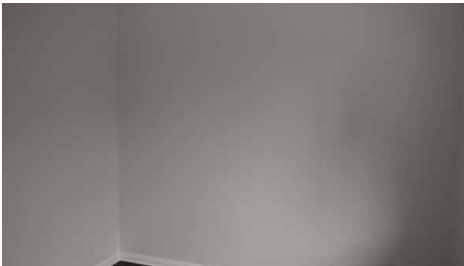
Wall Condition: In serviceable condition at the time of inspection

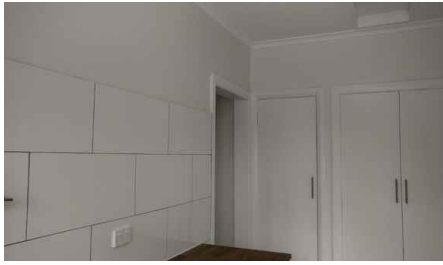
Ceilings Condition: In serviceable condition at the time of inspection

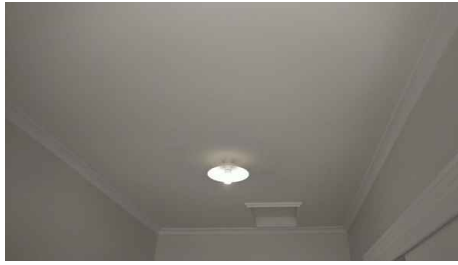
Floor Condition: In serviceable condition at the time of inspection

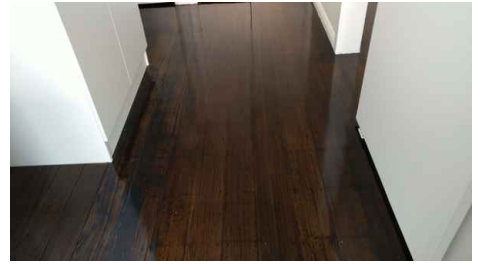
Splashback: In serviceable condition at the time of inspection

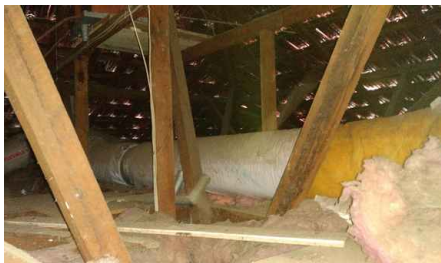
Roof Void Images

Rodent droppings observed., TV antenna in roof observed., Kitchen and/or bathroom vent fans are improperly venting into attic/roof void. Recommend extending fan exhaust to the exterior to prevent damage and/or deterioration from moisture and/or condensation., This roof void is insulated between rafters; no ventilation for roofing surface. Shingle life will be shorted with this arrangement.

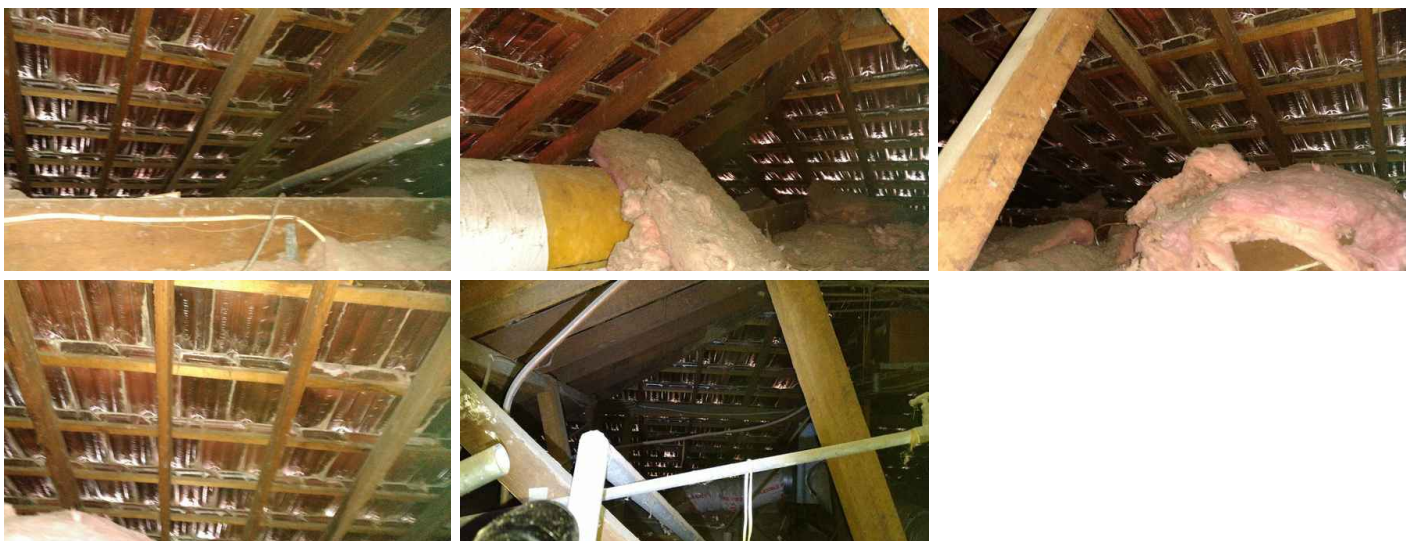
Roof Cladding Underside : Roof cladding appeared to be in serviceable condition

Please note. Not all areas are visible to the inspector, buyer needs to be aware these areas may contain hidden defects and these areas and items are excluded from the report. Requesting information from the vendor About known issues with the roof cladding is recommended.

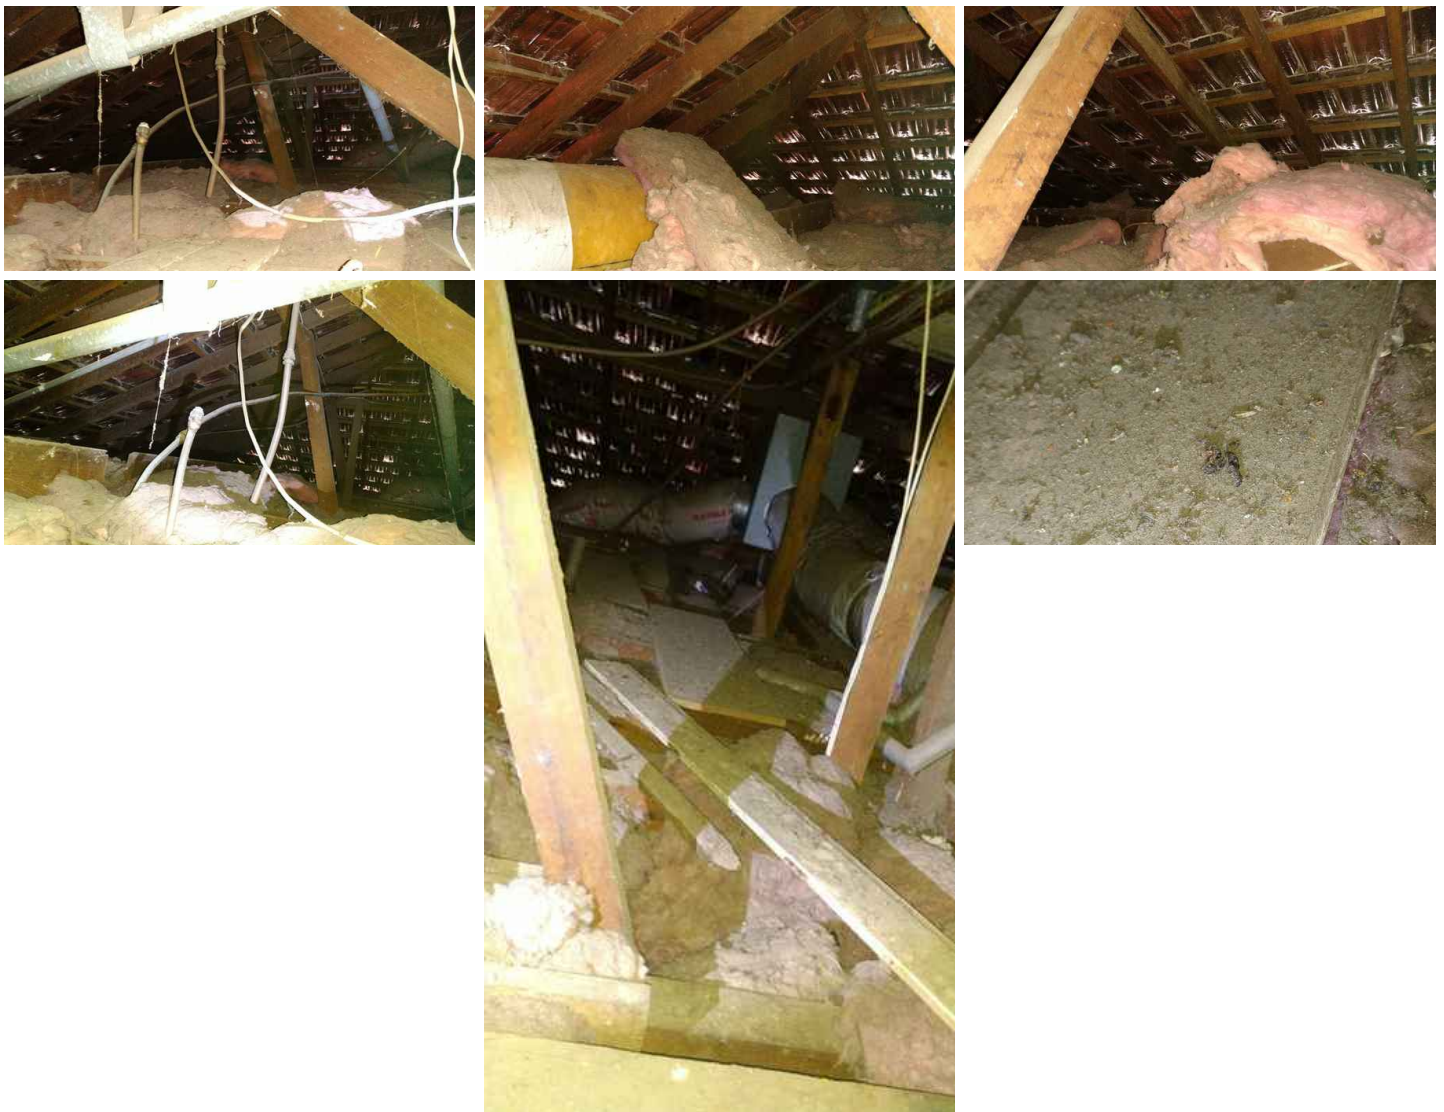
18.5.1 Ventilation

KITCHENOR/ BATH EXHAUST VENTS DIRECTLY INTO ROOF SPACE

Not recommended should be vented externally to ensure dirty air does not attract vermin to ceiling space.

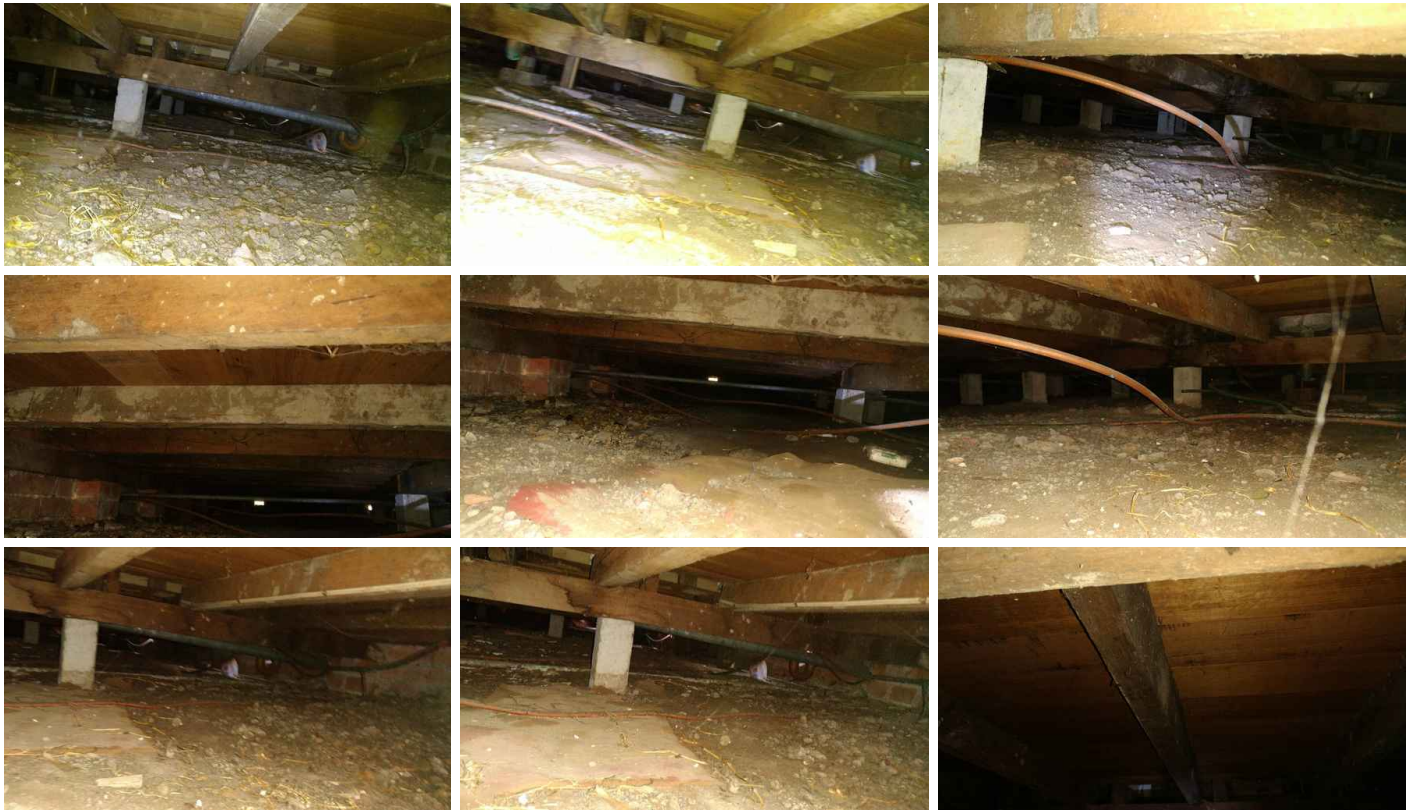
Sub-floor

Bearers/Joist Condition: The visibly accessible Beams and joists appear in serviceable condition relation to age

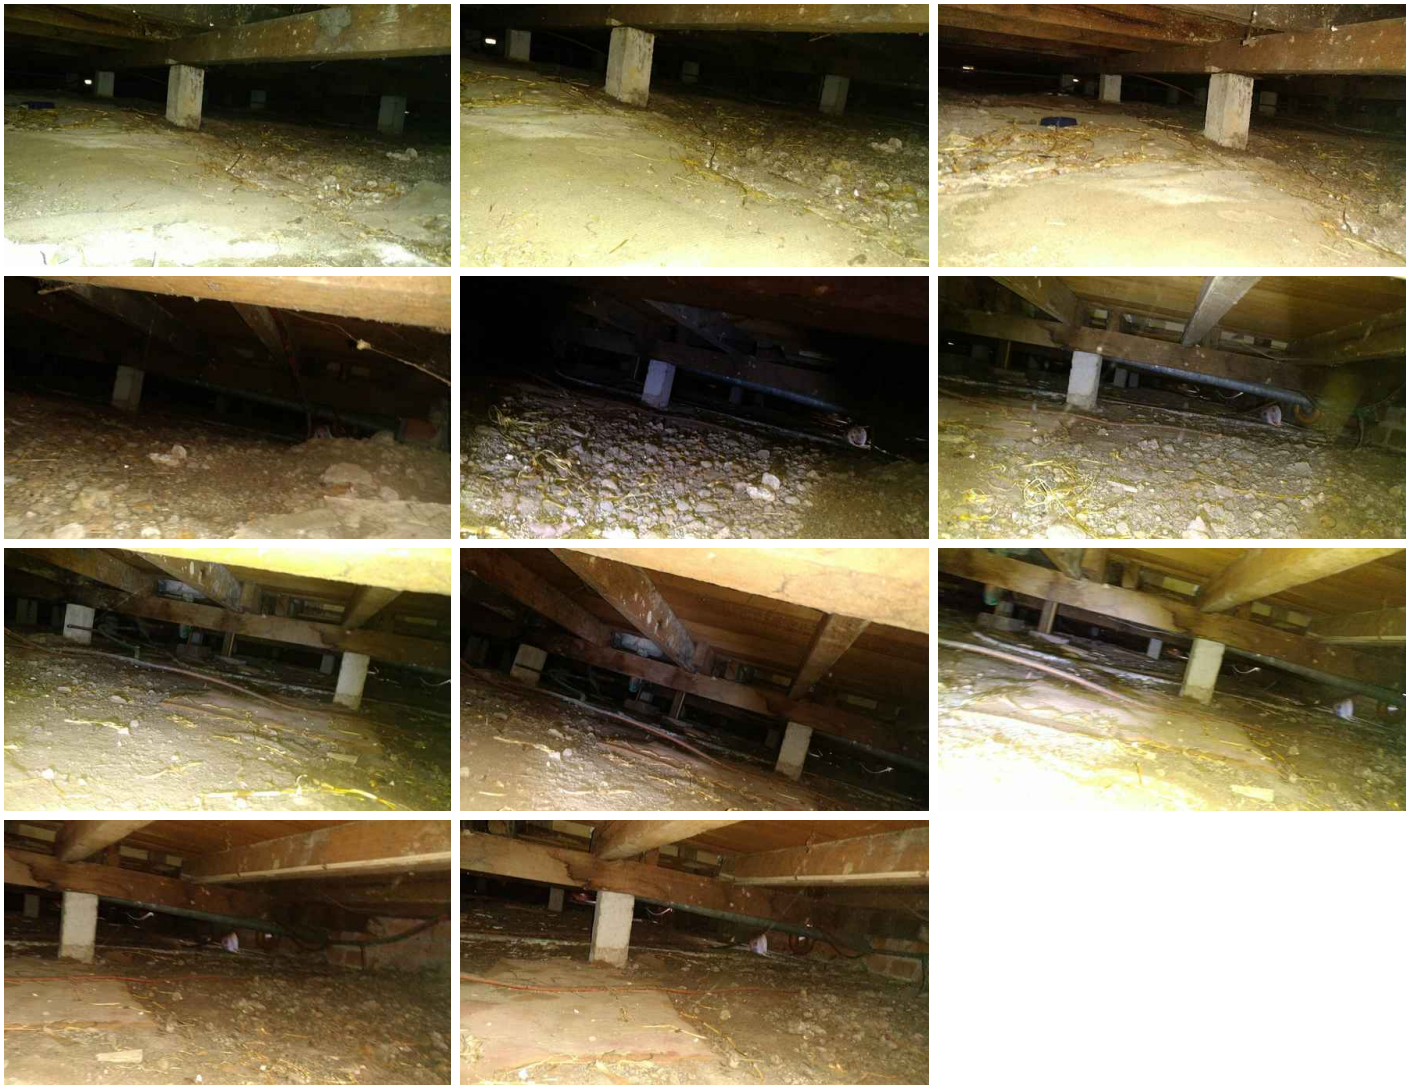
Support Post/stumps Comments: In serviceable condition at time of inspection
